Environmental Site Assessment and Hydrogeologic Impacts to Groundwater at St. Ignatius, Montana and Hanford, Washington

ENVIRONMENTAL SITE ASSESSMENT AND HYDROGEOLOGIC IMPACTS TO GROUNDWATER AT
ST. IGNATIUS, MONTANA AND HANFORD, WASHINGTON

Professional Portfolio

The first chapter, titled "An Environmental Site Assessment, St, Ignatius, Montana", is a Phase I commercial property environmental site assessment (ESA) report, completed on behalf of Pioneer Technical Services, Missoula, Montana (Carter, 2011). The chapter describes the purpose of the environmental assessment, limiting factors, site conditions, and results of visual observations at the site, findings, and conclusions. The entire report is included in this portfolio paper verbatim with minor edits for clarity. Research was focused on whether the property development had affected the local environment. This report touched on many of my academic interests including policy research, property development, and externalities impacting human and environmental health. This report was the first site assessment and characterization I completed since beginning my professional work in the environmental arena.

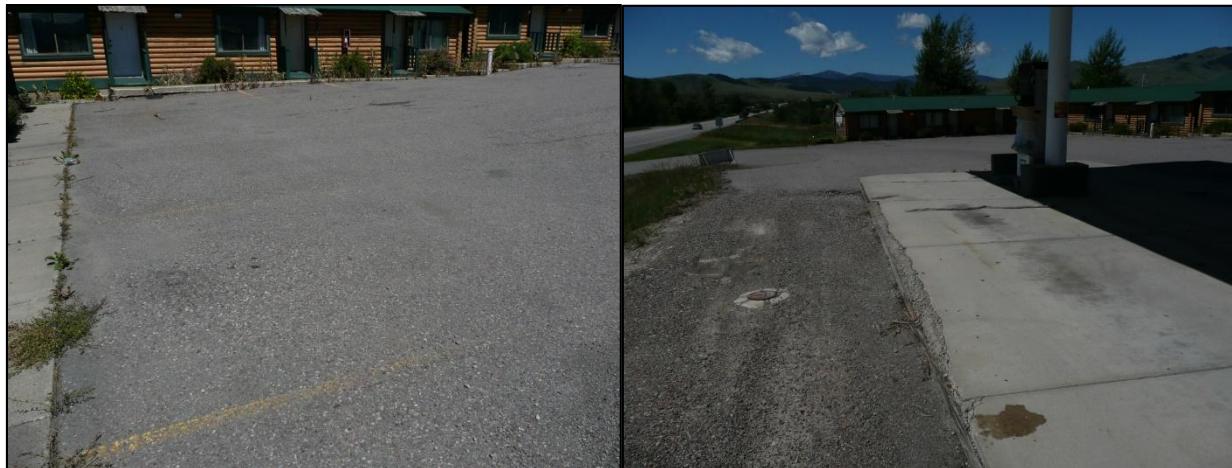
The parking lot appears to be in good condition, without any major cracks or potholes. Approximately 3,000 sq ft is asphalt, 250 sq ft is concrete, and 2,500 sq ft is gravel parking and drive-through. The restaurant parcel's parking area is completely graveled. According to satellite photos elevation records on Google Earth, the elevation on the north end is 2,907 feet asl (above sea level). There is a gentle down-slope to the south parking area at the motel, which is at 2,903 feet asl.

The subject property buildings are no longer used as intended. There are no disposed batteries, barrels or buckets visible on the property. There is minor staining at various locations on the asphalt parking lot indicating spills of oil or other products in isolated areas (Figure 4). The stains appear to be typical for the type of activity on the property and does not appear to pose a threat to the environment.

Figure 4. Views of the Paved Asphalt Parking Lot and Concrete Pad with Staining

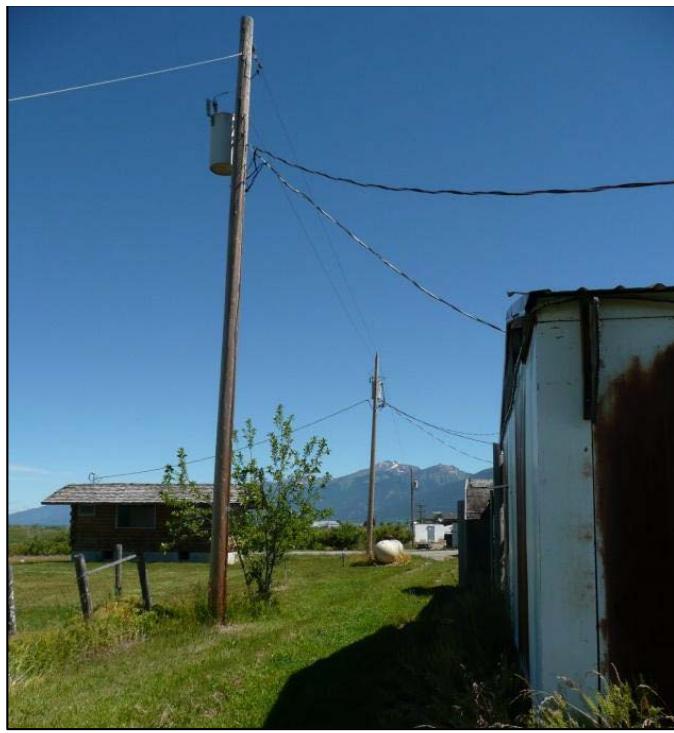
The electrical power to the site is supplied by a power pole located north of the White Buffalo Restaurant. There are six power poles on the subject property, three of which have transformers (Figure 6), and were observed to be modern transformers that Pioneer personnel did not suspect of containing PCBs (post-1977 construction of power lines). Pioneer did not contact Northwestern Energy to verify that the transformers do not contain PCBs.

Figure 6. View to the North of the Power-line Transformers

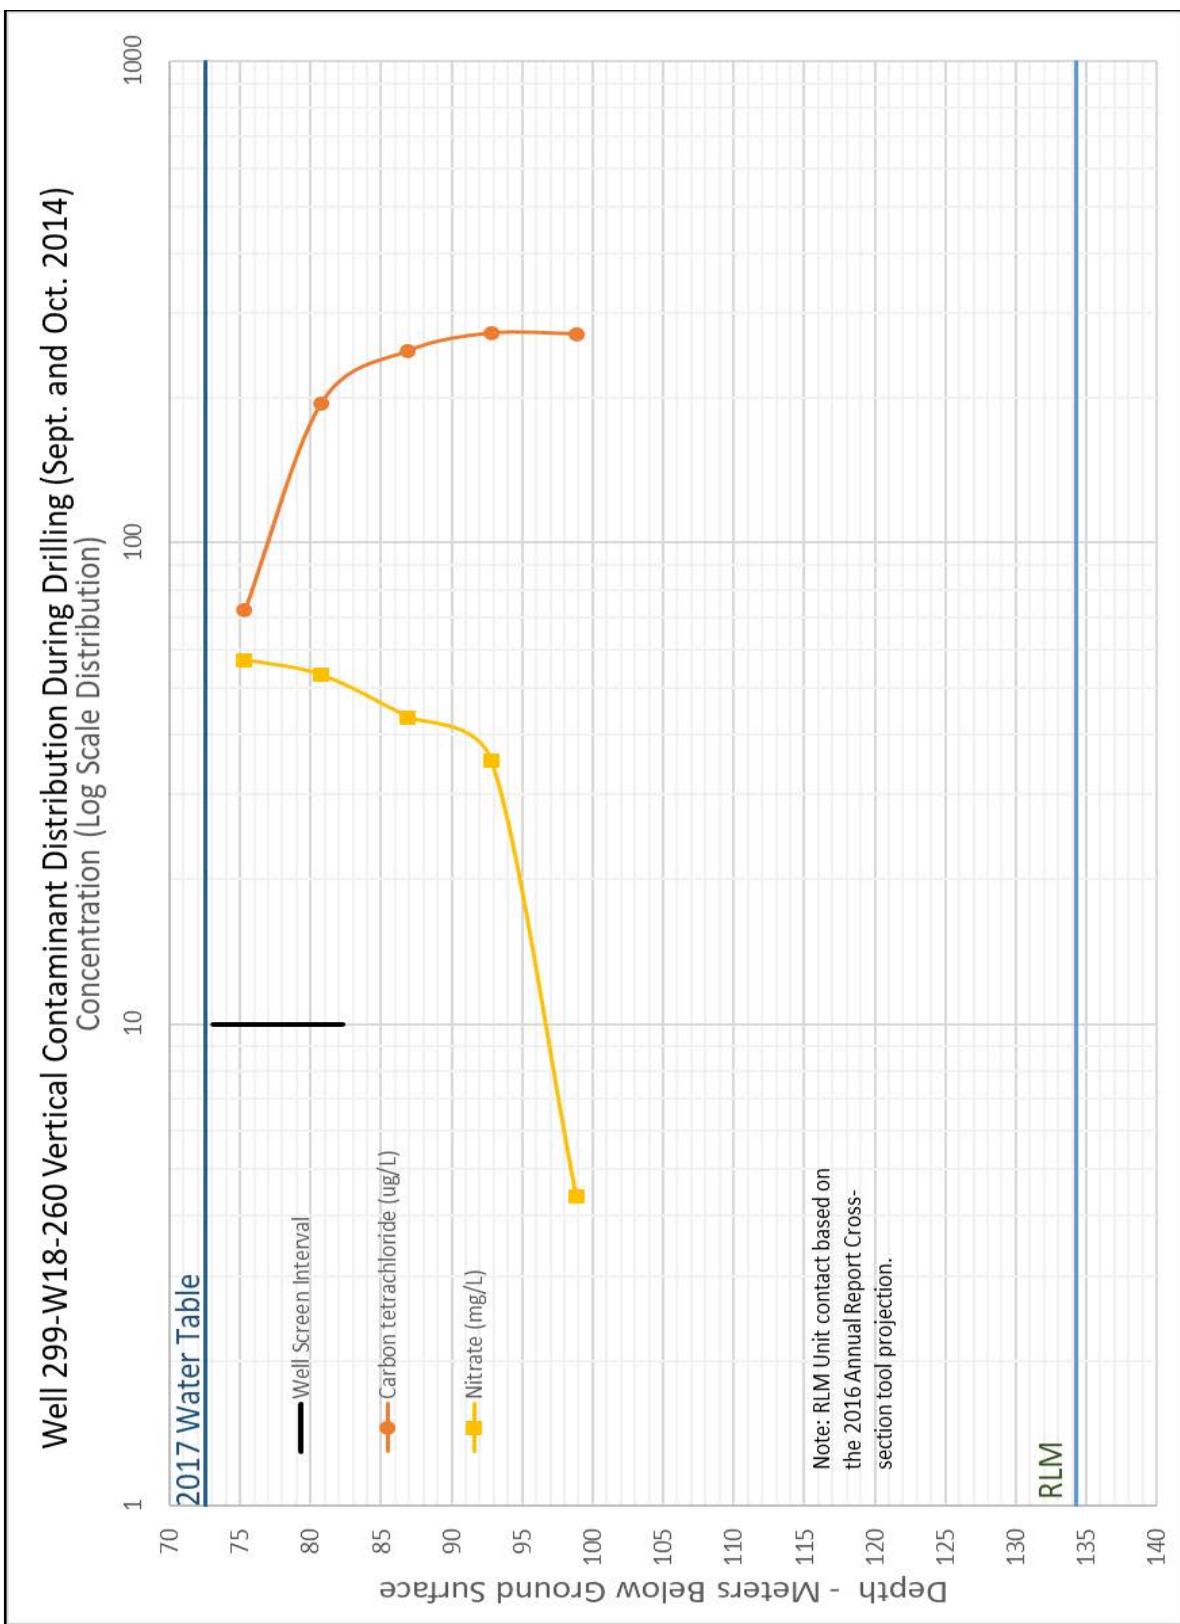
increase in carbon tetrachloride and nitrate concentrations beginning about 2 m (6.6 ft) and 8 m (26.2 ft), extending to 20 m (65.6 ft) and 25 m (82.0 ft), respectively, below the 2017 water table.

Figure 14. Vertical Contamination Distribution in Well 299-W18-260
