Baseline hydrological conditions Willow Creek Basin Valley County Montana

BASELINE HYDROLOGICAL CONDITIONS, WILLOW CREEK BASIN,
VALLEY COUNTY, MONTANA

Master of Science in Resource Conservation

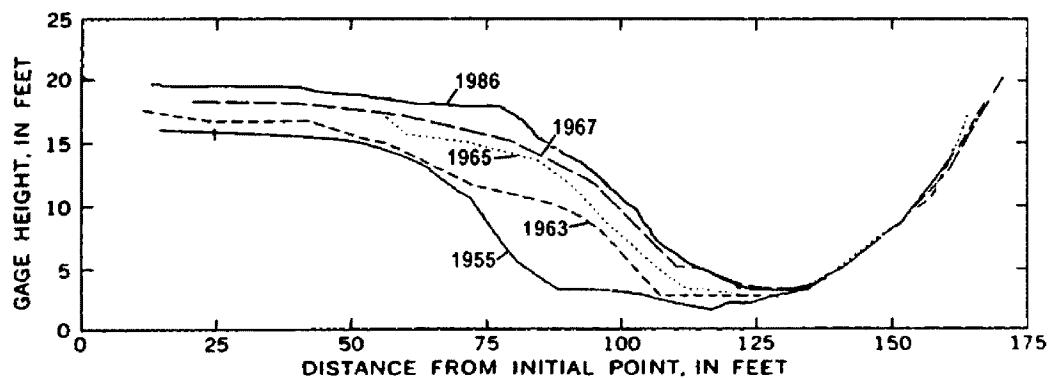
Runoff and sediment yield have been affected by the construction of the Willow Creek structures. However, without any hydrological data before the structures were in place, the magnitude of the effects cannot be compared. Frickel (1972) used runoff data collected by the U.S. Geological Survey in the 1960s to estimate that the conservation structures decreased the peak discharge of a large flood in 1962 by about 45 percent. At the Willow Creek gaging station, located at the lower end of Willow Creek, approximately 64 kilometers (40 stream miles) below Collins Reservoir, the width of the channel has narrowed significantly since 1955 (figure 2).

Figure 2. *Channel cross-section at Willow Creek gaging station (Frickel 1972).*

This change is probably the result of reduced peak discharges and reduced flows brought about by the detention reservoirs and the hundred retention livestock ponds within the basin.

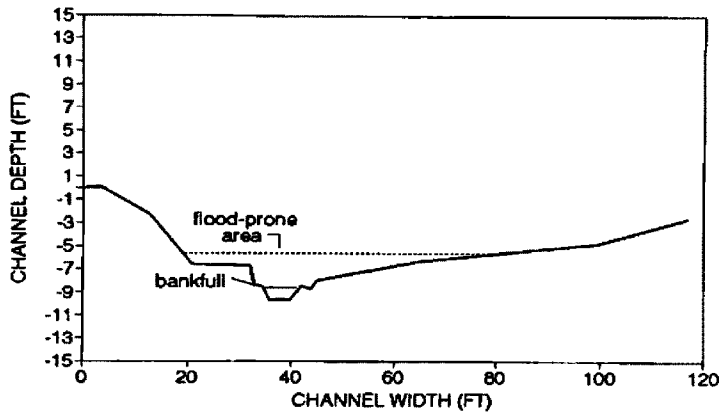
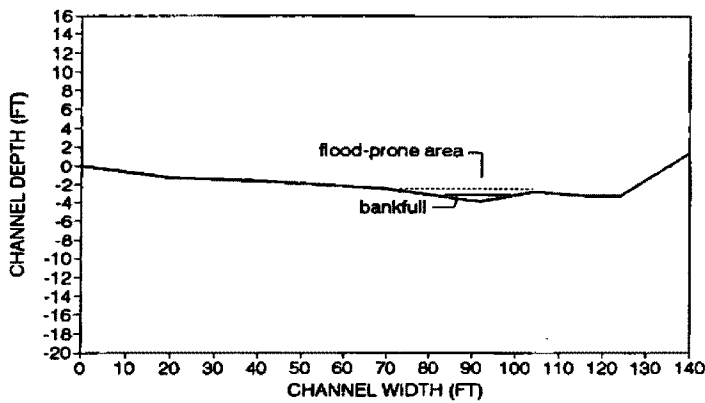
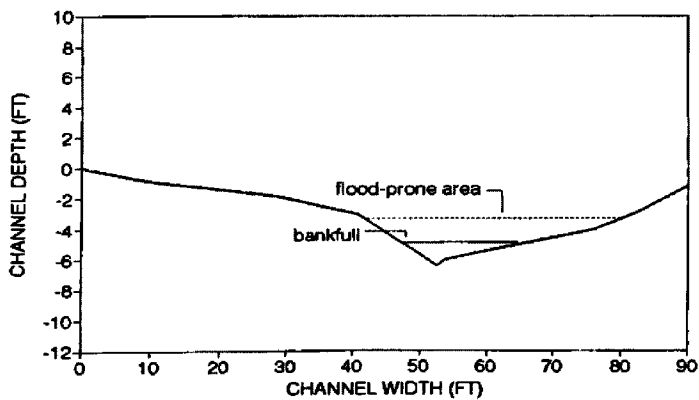
Figure 8. Cross-section graphs above Sheepshed Reservoir.

channels and cross-section 6 is a Rosgen C6 channel. Graphs of the cross-sections are shown in figures 8 and 9. The measured values for classifying channel types are listed in Appendix A-1. Sheepshed has a much smaller drainage area than the other basins in the study. Because of there is less runoff into the channel from overland flow, which lessens the erosive impacts from the water moving through the system.

channel type: C6
 entrenchment: 5.3
 width/depth: 14.9
 slope: 0.0009
 sinuosity: 3.0

channel type: C6
 entrenchment: 1.5
 width/depth: 32.5
 slope: 0.0009
 sinuosity: 3.0

channel type: C6
 entrenchment: 5.7
 width/depth: 17.0
 slope: 0.009
 sinuosity: 3.0

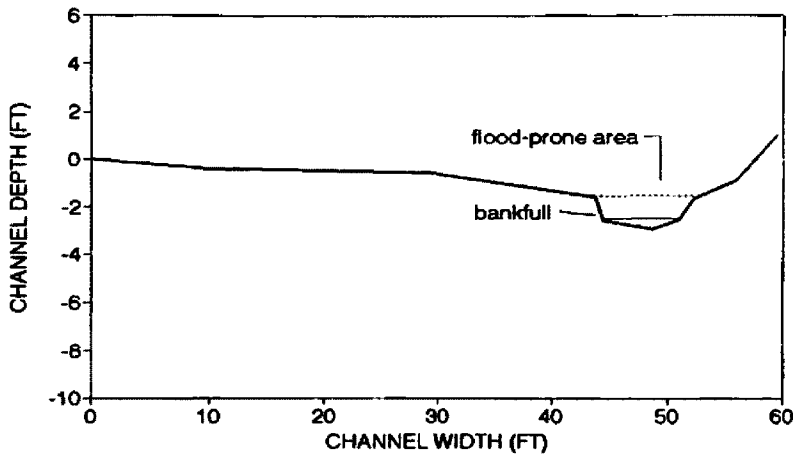
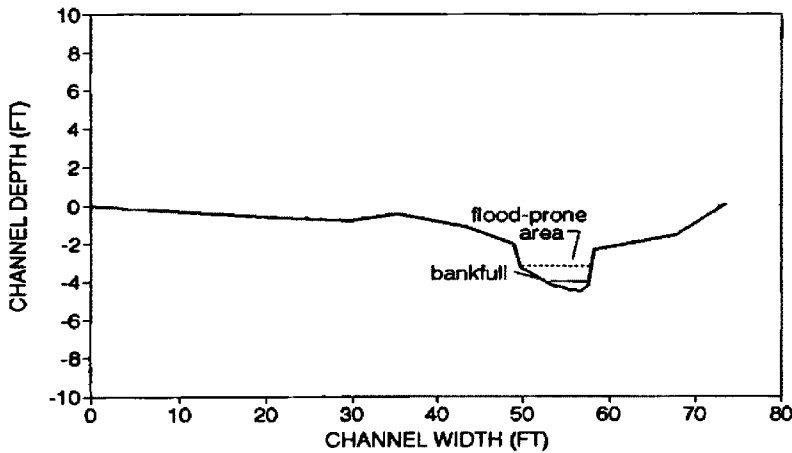
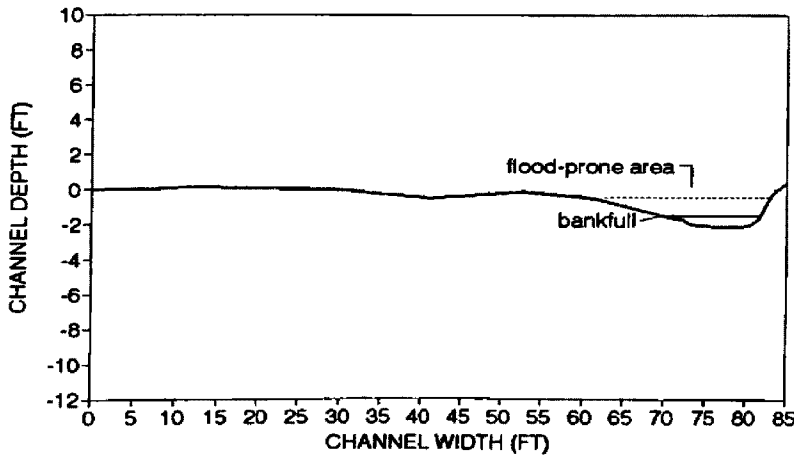
Figure 9. Cross-section graphs below Sheepshed Reservoir.

channel type: F6
 entrenchment: 1.3
 width/depth: 28.3
 slope: 0.006
 sinuosity: 2.0

channel type: F6
 entrenchment: 1.9
 width/depth: 29.1
 slope: 0.006
 sinuosity: 2.0

channel type: C6
 entrenchment: 1.7
 width/depth: 34.1
 slope: 0.006
 sinuosity: 2.0

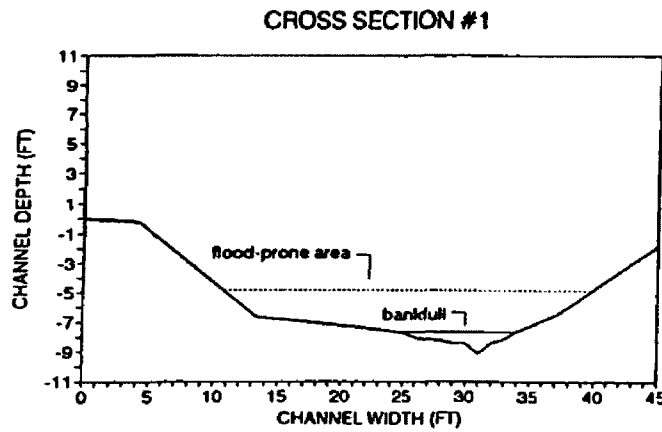
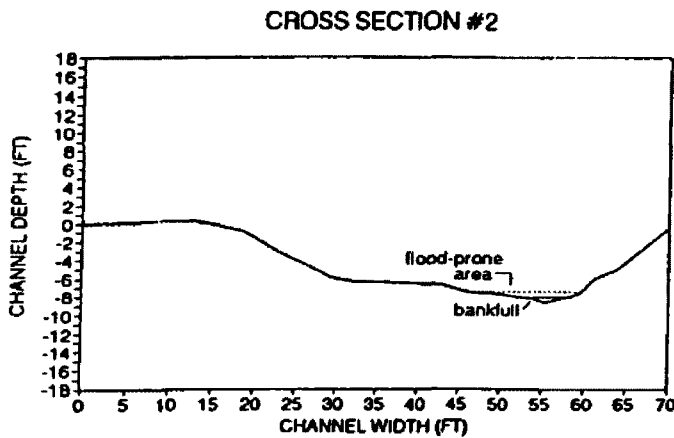
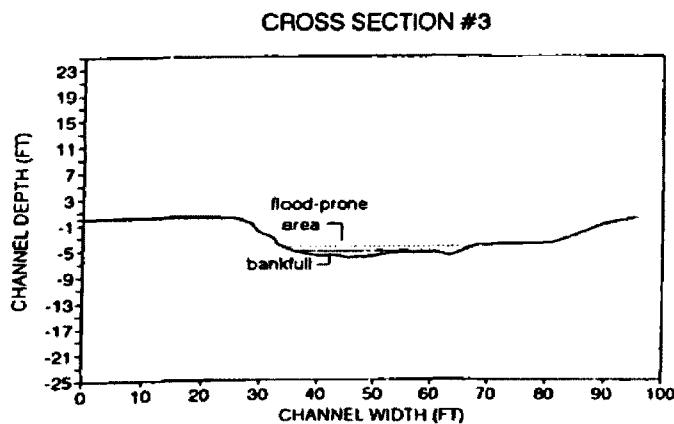
Figure 10. Cross-section graphs above Camp Reservoir.

Above Camp Reservoir all reaches surveyed are Rosgen C6 channel types. All cross-sections below Camp are Rosgen G-type channels (figures 10 and 11). The fact that the channel below Camp is virtually a gully is not surprising due to the fact that the dam was built at the site of a major headcut. If the structure had not been put in, the headcut would more than likely have continued to advance up the channel.

channel type: C6
 entrenchment: 3.2
 width/depth: 20.2 f
 slope: 0.003
 sinuosity: 1.4

channel type: C6
 entrenchment: 4.6
 width/depth: 15.8 f
 slope: 0.003
 sinuosity: 1.4

channel type: C6
 entrenchment: 2.6
 width/depth: 57.9
 slope: 0.003
 sinuosity: 1.4

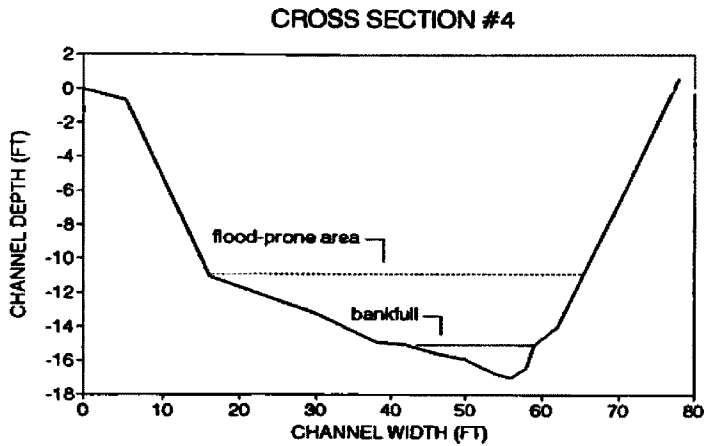
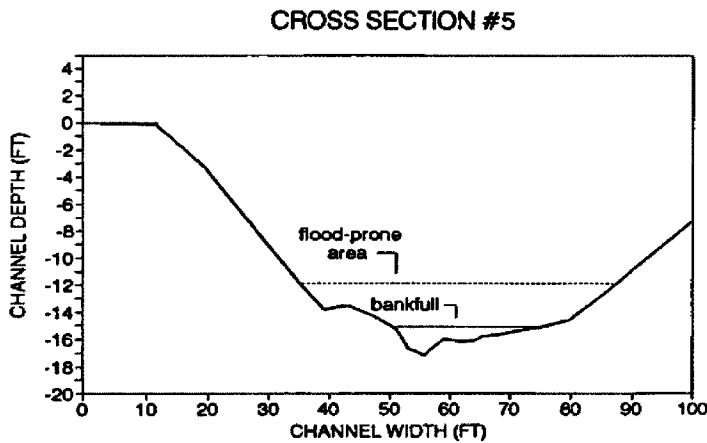
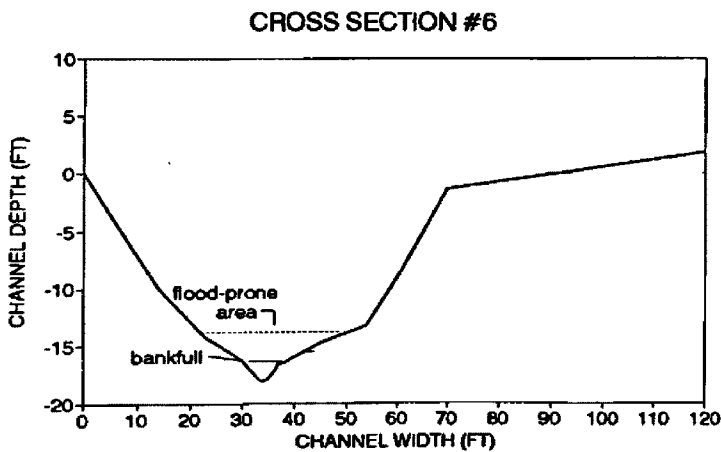
Figure 11. Cross-section graphs below Camp Reservoir.

channel type: G6
 entrenchment: 2.6
 width/depth: 20.2
 slope: 0.003
 sinuosity: 1.6

channel type: G6
 entrenchment: 2.3
 width/depth: 16.9
 slope: 0.003
 sinuosity: 1.6

channel type: G6
 entrenchment: 2.6
 width/depth: 8.7
 slope: 0.003
 sinuosity: 1.6

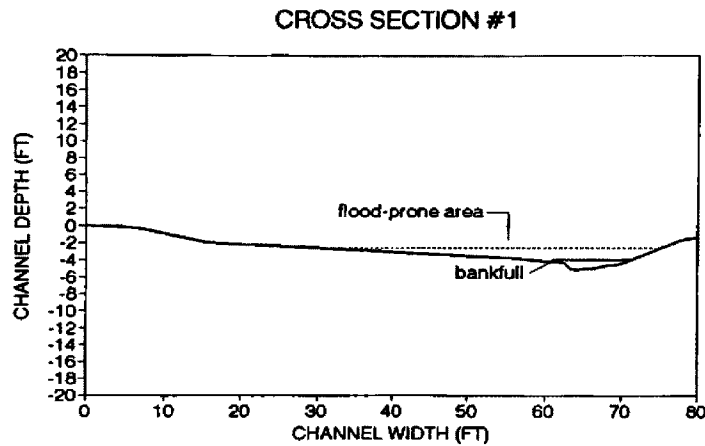
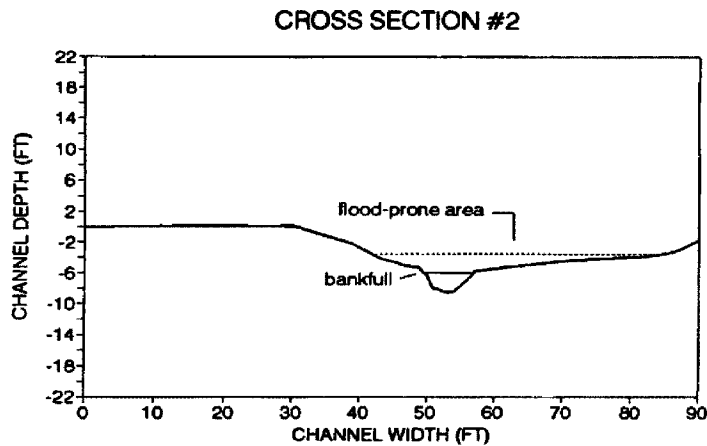
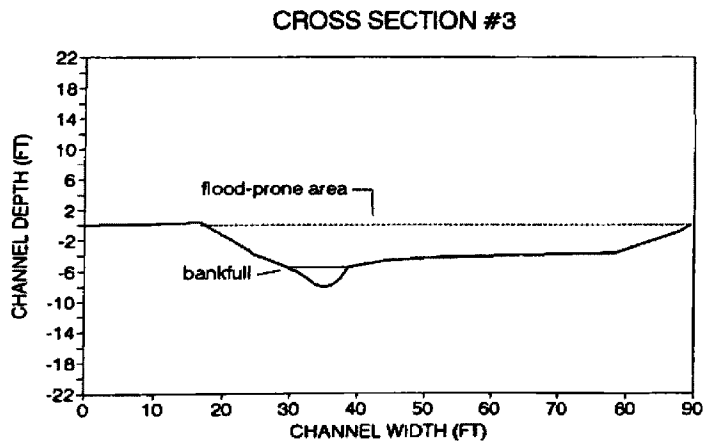
Figure 12. Cross-section graphs above Mudpot Reservoir.

The cross-sections of the channel above Mudpot Reservoir are Rosgen C6 stream types, while the cross-sections below are all Rosgen G6 stream types (figures 12 and 13). Like Camp, Mudpot was also constructed at the site of a major headcut, and therefore the channel below is classified as a G, or a gully. Once again the structure prevented the headcut from advancing up the channel.

channel type: C6
 entrenchment: 5.0
 width/depth: 20.6
 slope: 0.0009
 sinuosity: 1.3

channel type: C6
 entrenchment: 5.9
 width/depth: 5.8
 slope: 0.0009
 sinuosity: 1.3

channel type: C6
 entrenchment: 10.7
 width/depth: 6.3
 slope: 0.0009
 sinuosity: 1.3

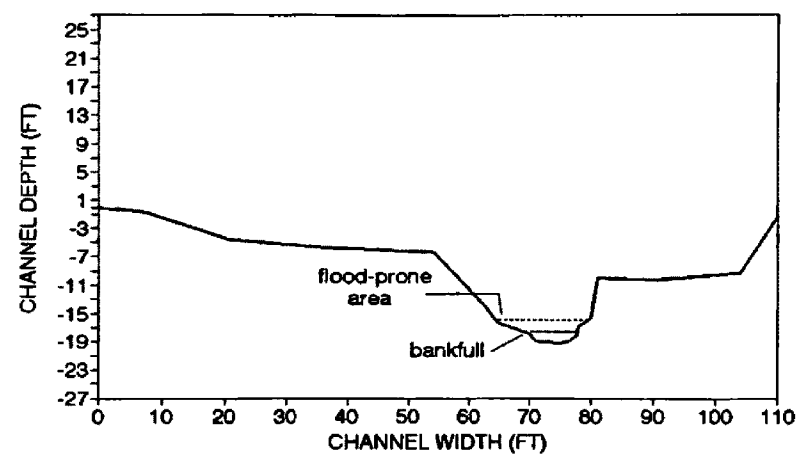
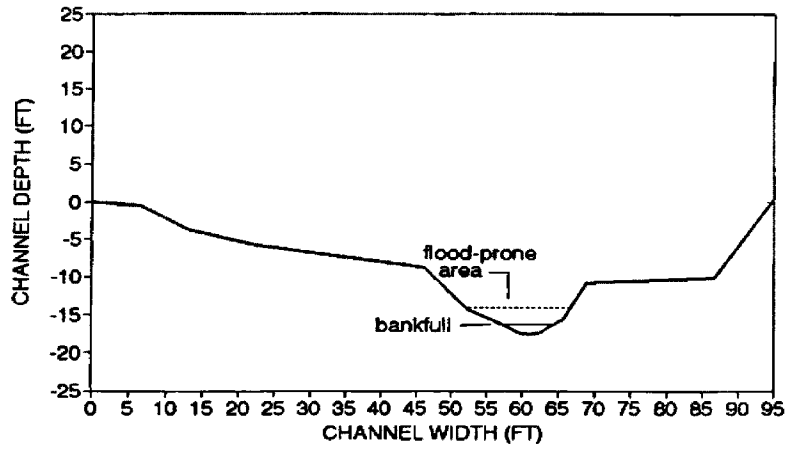
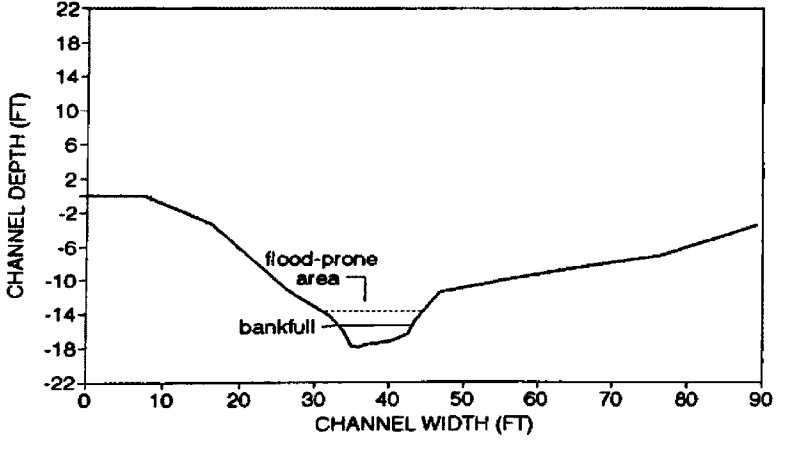
Figure 13. Cross section graphs below Mudpot Reservoir.

channel type: G6
entrenchment: 2.4
width/depth: 6.8
slope: 0.0004
sinuosity: 1.7

channel type: G6
entrenchment: 2.2
width/depth: 7.7
slope: 0.0004
sinuosity: 1.7

channel type: G6
entrenchment: 2.0
width/depth: 9.2
slope: 0.0004
sinuosity: 1.7

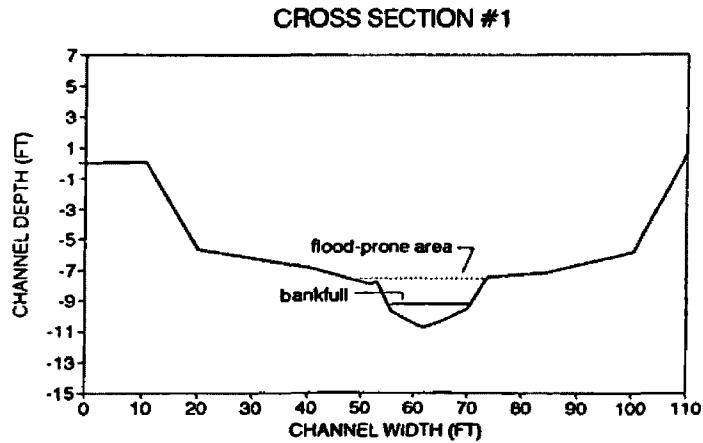
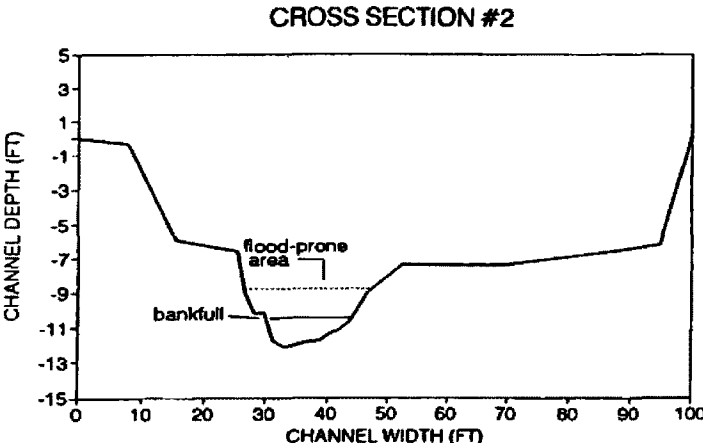
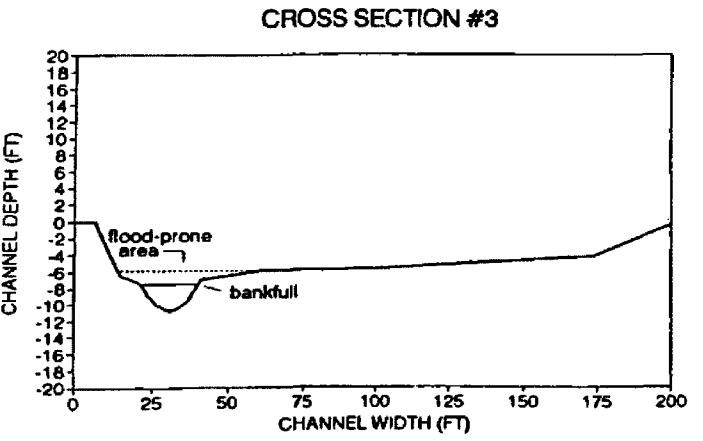
Figure 14. Cross-section graphs above Forest Reservoir.

Using Rosgen's classification system, six channel reaches were surveyed. The graphs of these cross-sections are shown in figures 14 and 15. Cross-sections one and two are F6 channel types. Cross-sections three through six are C6 channel types. Unlike Camp, Collins, and Mudpot reservoirs, Forest was not constructed at the site of a major headcut. Therefore there is not the extreme change in channel types from above or below the reservoir.

channel type: F6
entrenchment: 1.8
width/depth: 20.5
slope: 0.0002
sinuosity: 1.3

channel type: F6
entrenchment: 1.6
width/depth: 20.0
slope: 0.0002
sinuosity: 1.3

channel type: C6
entrenchment: 5.2
width/depth: 11.4
slope: 0.0002
sinuosity: 1.3

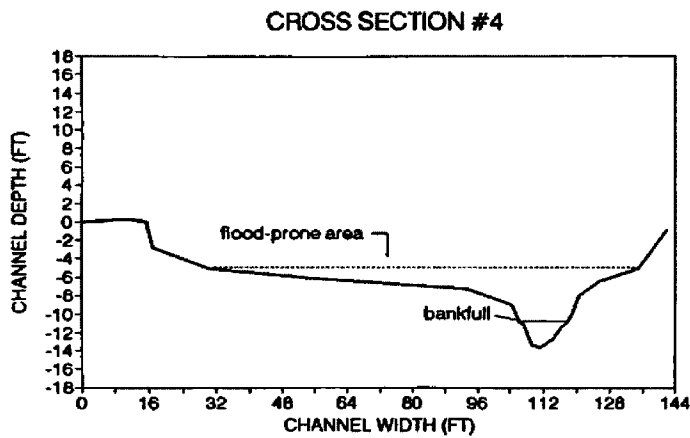
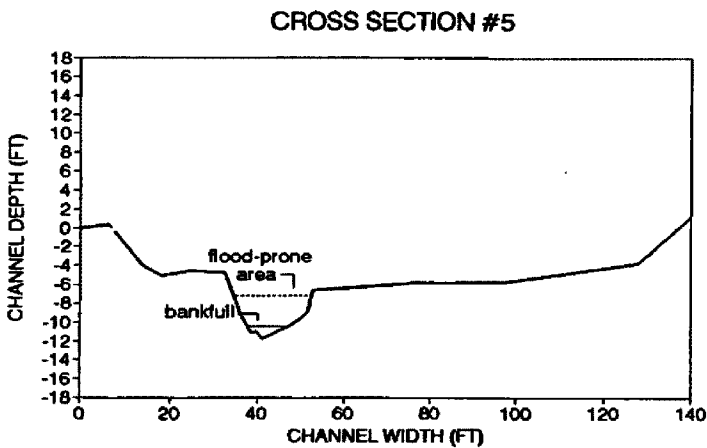
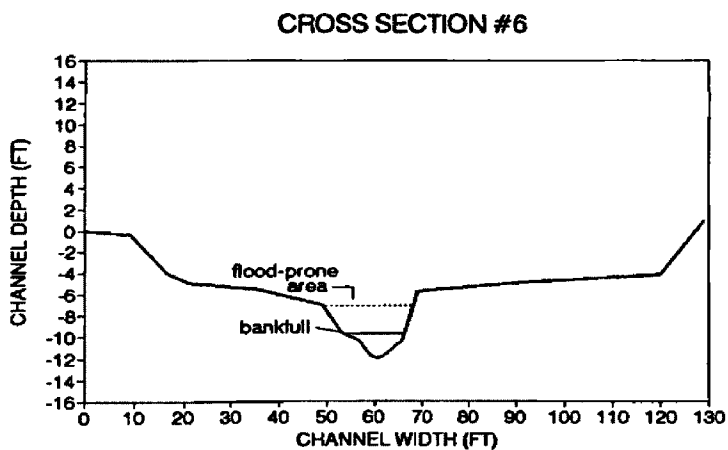
Figure 15. Cross-section graphs below Forest Reservoir.

channel type: C6
 entrenchment: 7.0
 width/depth: 8.9
 slope: 0.0005
 sinuosity: 1.4

channel type: C6
 entrenchment: 2.3
 width/depth: 13.4
 slope: 0.0005
 sinuosity: 1.4

channel type: C6
 entrenchment: 2.1
 width/depth: 10.2
 slope: 0.0005
 sinuosity: 1.4

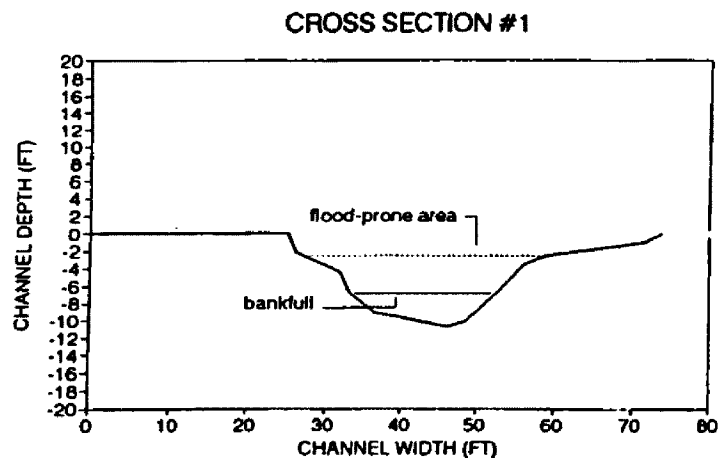
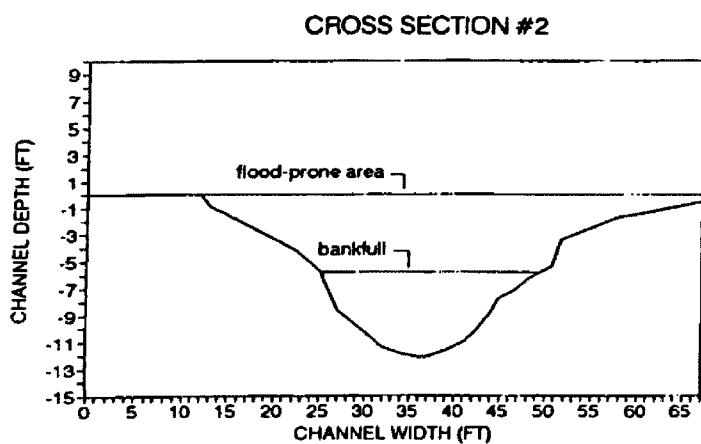
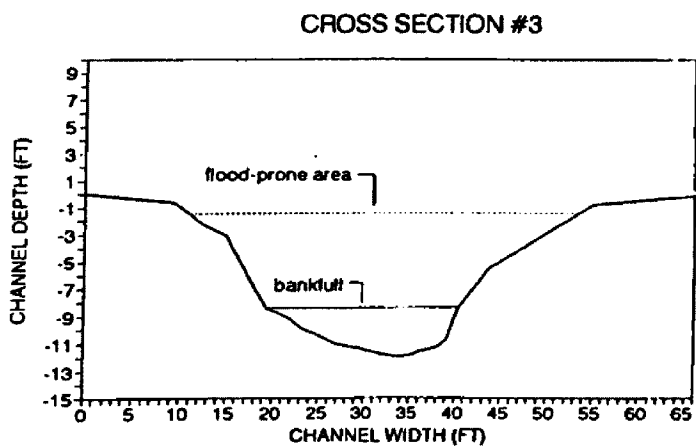
Figure 16. Cross-section graphs above Collins Reservoir.

Graphs of the cross-sectional views are shown in figures 16 and 17. Cross-sections one and two above Collins are classified as C6 channel types, while cross-sections three through six are G-type channels. Collins Dam, like Camp and Mudpot was constructed at the site of a major headcut. Because of this the channels below were deeply incised gullies. These channels are still classified as gullies; however, there is obvious improvement taking place. A new floodplain is developing within the old incised channel and vegetation is being established. The C-type channels above indicate, once again, that the structures were successful in stopping the advancement of the headcut.

channel type: C6
 entrenchment: 1.9
 width/depth: 6.9
 slope: 0.001
 sinuosity: 1.2

channel type: C6
 entrenchment: 3.0
 width/depth: 6.0
 slope: 0.001
 sinuosity: 1.2

channel type: G6
 entrenchment: 2.1
 width/depth: 8.5
 slope: 0.001
 sinuosity: 1.2

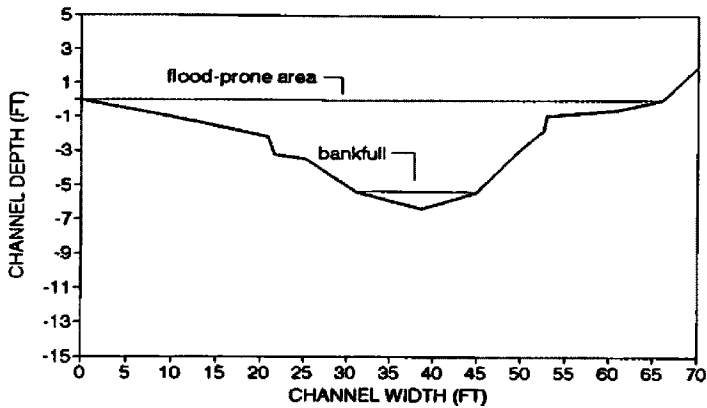
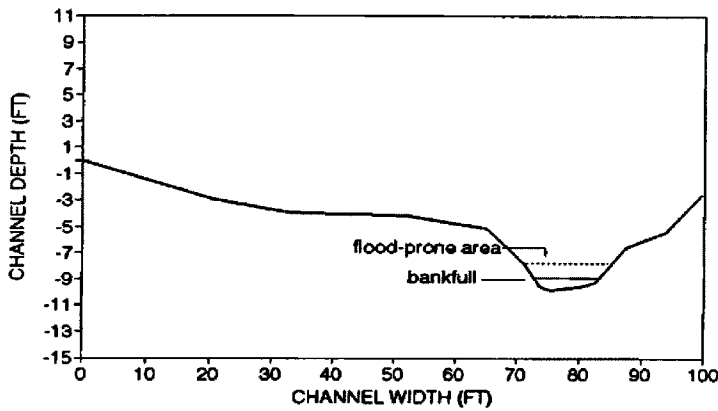
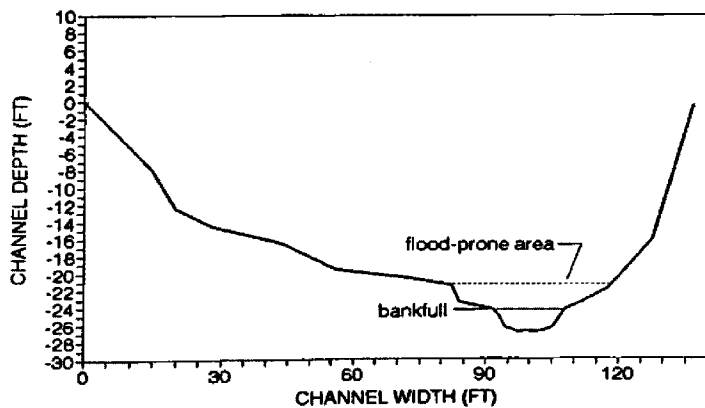
Figure 17. Cross-section graphs below Collins Reservoir.

channel type: G6
 entrenchment: 3.8
 width/depth: 10.1
 slope: 0.0007
 sinuosity: 2.5

channel type: G6
 entrenchment: 1.2
 width/depth: 25.0
 slope: 0.0007
 sinuosity: 2.5

channel type: G6
 entrenchment: 2.1
 width/depth: 8.4
 slope: 0.0007
 sinuosity: 2.5

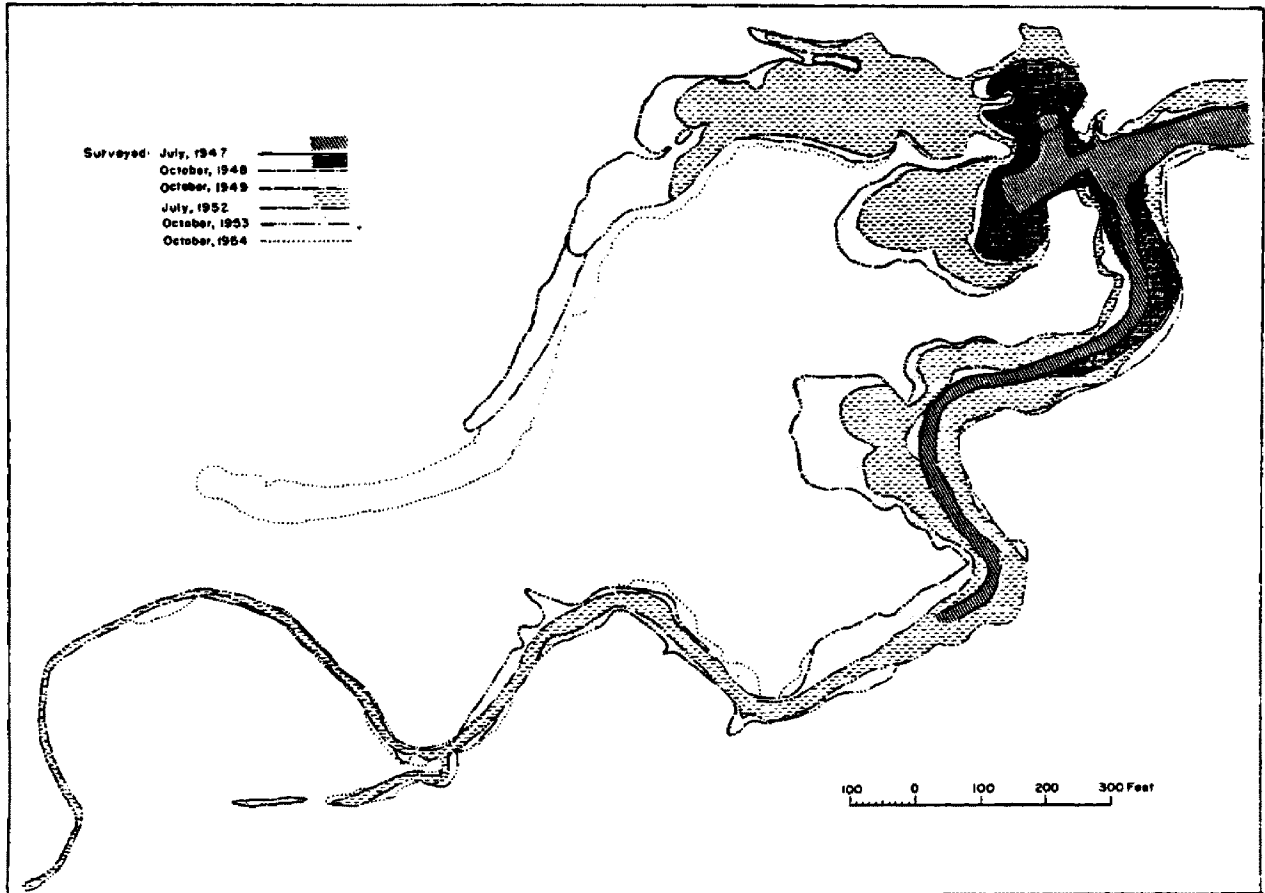
Figure 18. Advancement of the headcut at Collins Reservoir (1947-1954)
(Miller 1987).
