Cottonwood Creek Preliminary Assessment

*John Lhotak, Jeff Dunn, Victoria Edwards, Michael Sanctuary,
Gary Hughes, Matt Vitale
University of Montana, Environmental Studies*

Purpose – to describe the current condition of Cottonwood Creek

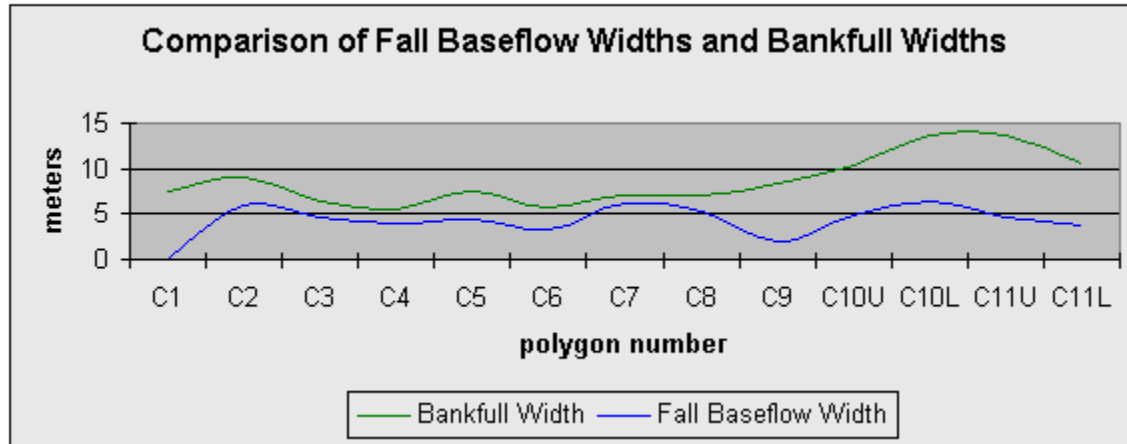
Figure 1 illustrates the relationship of the bankfull widths and the fall baseflow widths. Upstream of polygon C9, baseflow width closely tracks the bankfull width. C1 is located on Baggs Creek which was not flowing at the time. The difference between baseflow and bankfull width increase downstream. This could be the result of ground water-surface water interaction, dewatering, and/or

grazing activities. The bankfull width drops at C11L because the creek has been armored to align the creek with the culvert going under the highway.

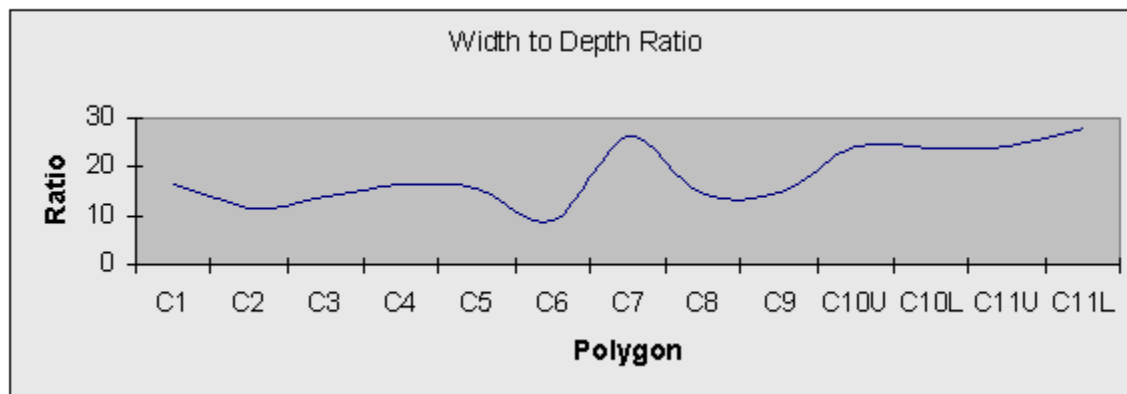
Figure 2 shows the width to depth ratio of Cottonwood Creek from polygon C1 to C11. Rosgen (1996) states that as the width to depth ratio increases the hydraulic stress increases, accelerating bank erosion. This causes the stream to continue to widen. The ratio also illustrates a widening trend downstream from polygon C1; as the ratio increases, the stream becomes wider and more shallow. There is a noticeable drop in the width to depth ratio in polygon C6 because the creek banks in C6 are well stabilized by willows. In polygons C10U to C11L, the greater the width to depth ratio may be due to grazing and the herbaceous-dominated understory.

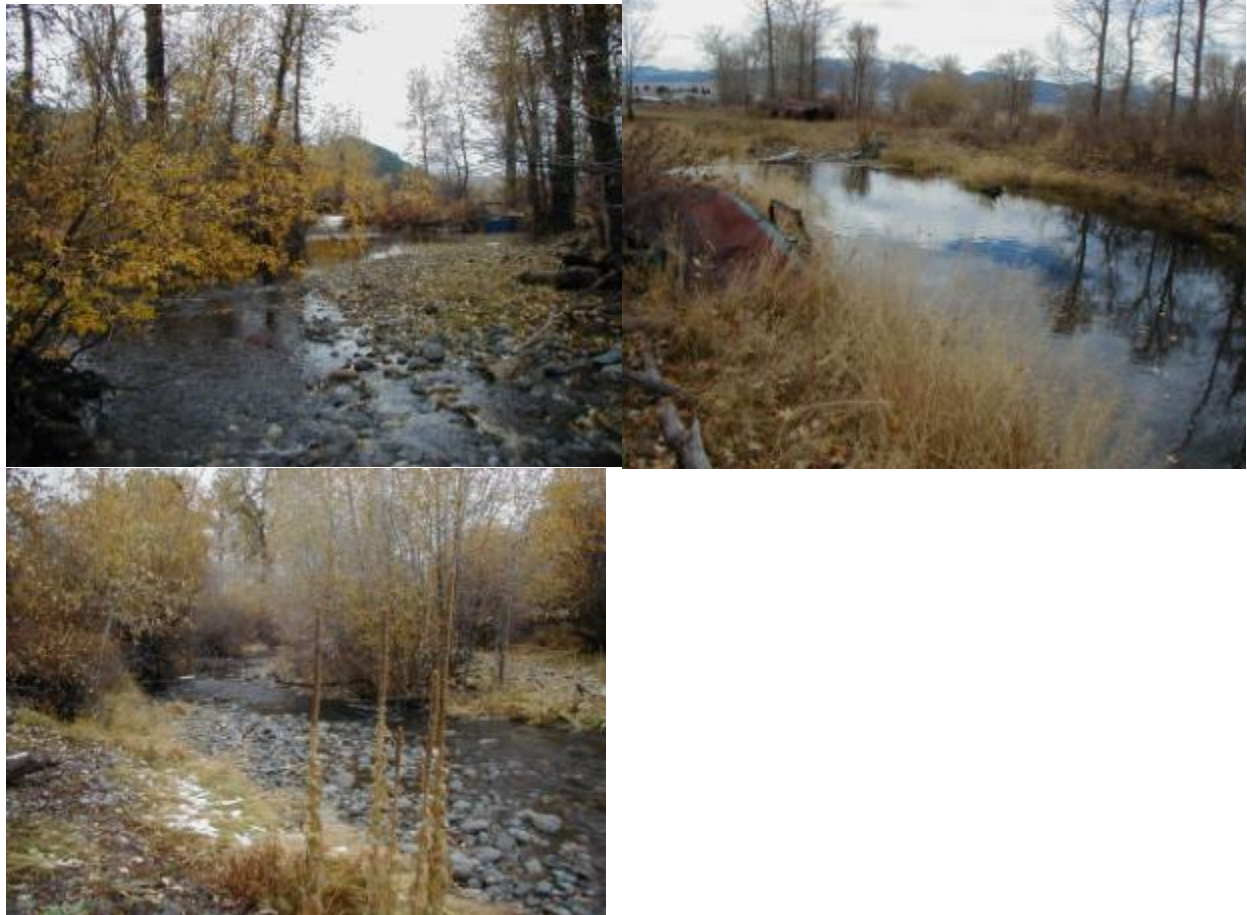
Of the 15 polygons assessed using the RWRP Lotic Health Assessment, five were found to be functioning but at risk, and the remaining ten polygons were found to be non-functioning systems. See Appendix A for a summary table of the RWRP assessment forms. The major concerns along the riparian areas include overgrazing, dewatering and invasive plants. All but 3 polygons are dominated by mature *Populus trichocarpa* (black cottonwood) stands. Most of the undergrowth in these stands has been grazed over and little, if any, *P. trichocarpa* (black cottonwood) regeneration is occurring. This is especially the case in Polygons C9, C10 and C11.

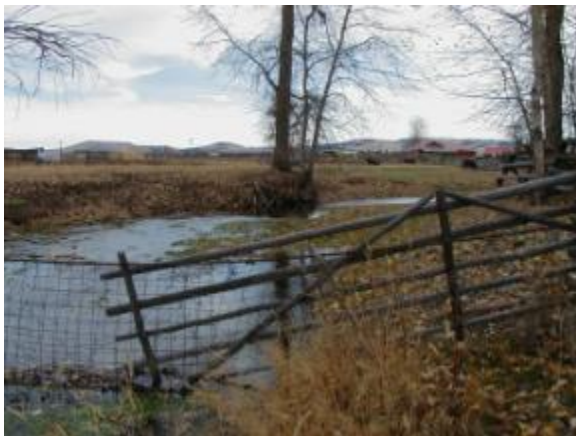
Site One

One of the project sites (a water gap removal) located in polygon C-10 had heavy erosion with corrals directly in the stream. Such an impacted site has the potential for significant groundwater / surface water interactions (Allan, 1995). The results of discharge measurements taken on 10/20 might indicate there is some groundwater / surface water interactions taking place.

The removal of the watergaps along the creek and fencing off a 30 foot riparian buffer will have a positive effect for the creek (Ehrhart and Hansen 1998). Providing a riparian buffer will reduce nutrients entering the creek. Since site one is a *Populus trichocarpa* / Herbaceous (black cottonwood / Herbaceous) community type, there may be problems with revegetation of the riparian zone if the water table has been lower drastically. However, it is possible the water table has not dropped significantly since the general geology of the area has a higher water table (Nimick et al. 1993). If revegetation is successful, woody species along the creek will help to control the widening of the creek, help with bank building, and provide fish habitat (Ehrhart and Hansen 1998).
