Functioning Floodplains from the Top Down

BIG HOLE
WATERSHED COMMITTEE

Scaling treatments to address source of degradation

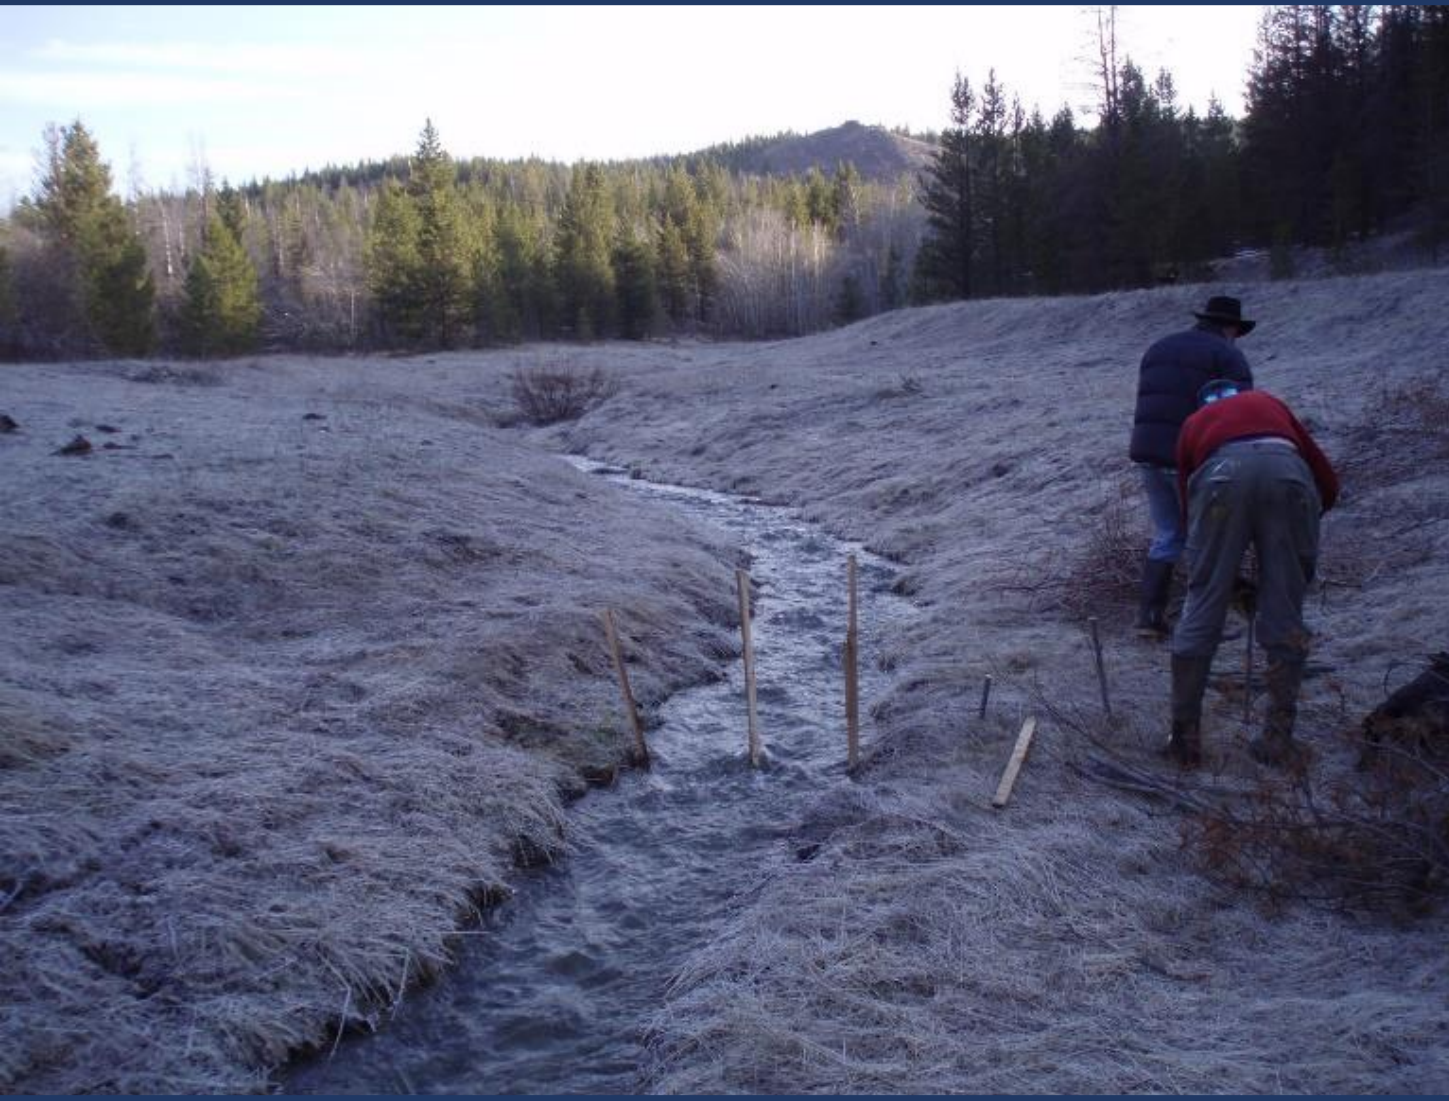
May 2016

Slow the water, connect floodplain, soak the soil

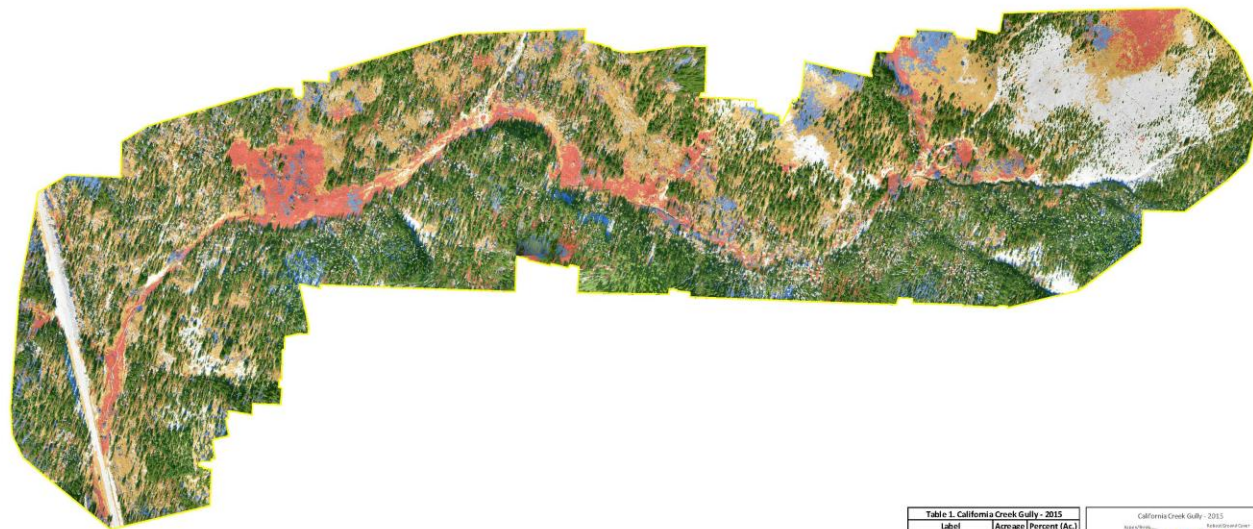
Table 1. California Creek Gully - 2015		
Label	Average	Percent (Ac.)
Robust Ground Cover	23.7	10%
Degraded Vegetation	52.3	23%
Bare Ground	31.2	14%
Coniferous Forest	106.6	47%
Aspen/Shrub	15.8	7%
Total	222.7	100%

Mount Haggitt - Aerial - California Creek Gully - Oct. 15, 2015	
California Creek Gully Vegetation Classification - 2015	
DATE REVISIONS	SHEET C4
Drawn: 3/1/2020	
By: [Name]

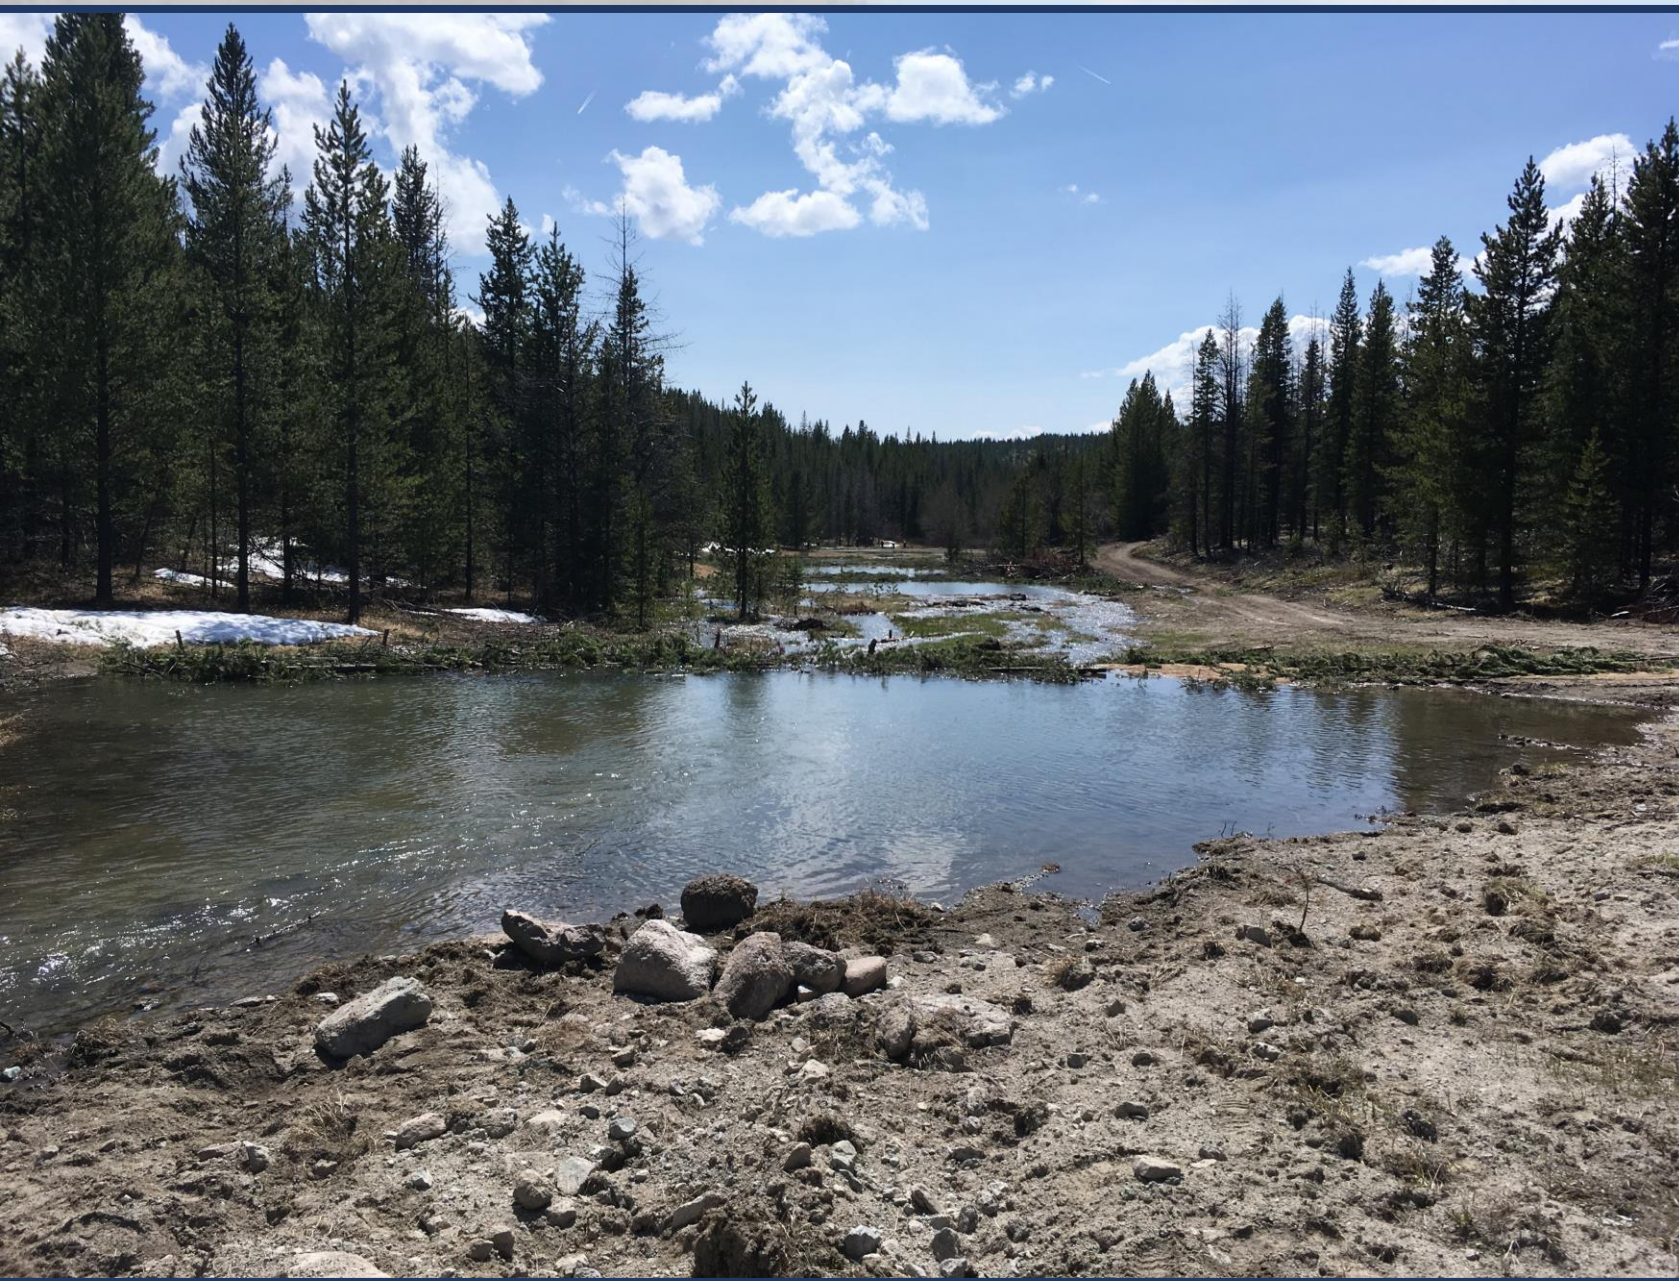
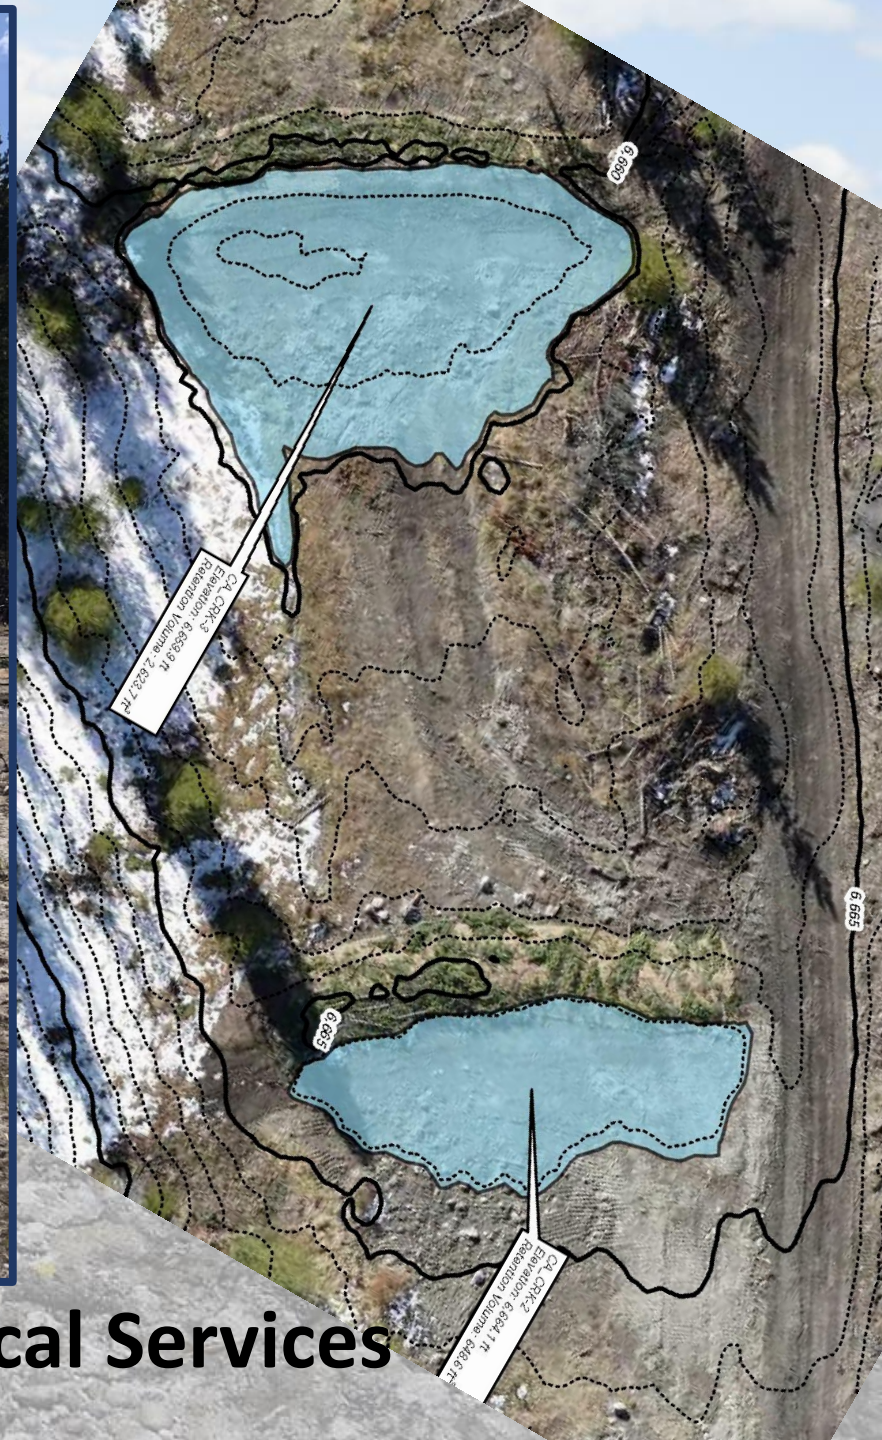
Spreader Dikes- Pioneer Technical Services

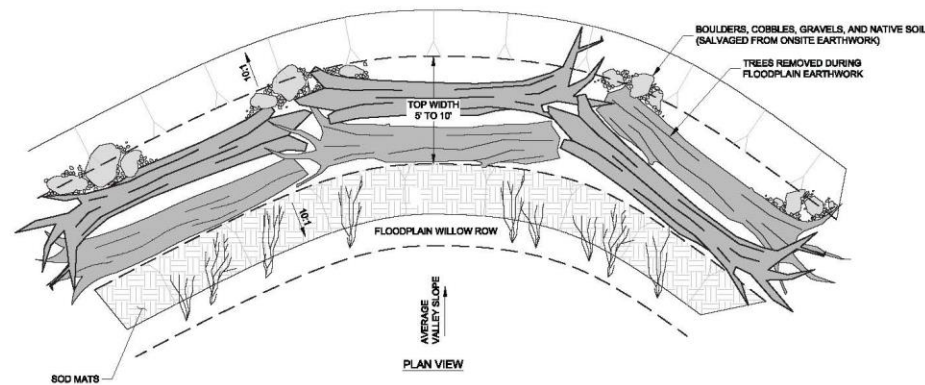
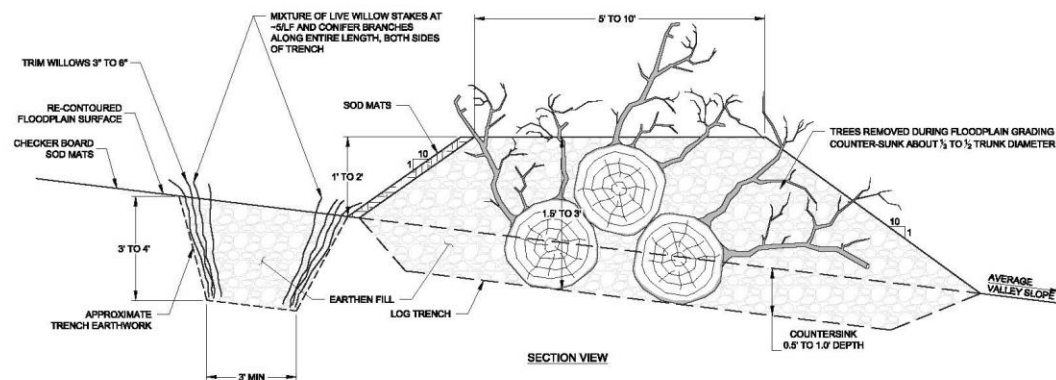
DETENTION RIDGE DETAIL
SCALE: NONE
1
C-2

- NOTES:
1. FINAL LOCATIONS AND LENGTH WILL BE DIRECTED IN FIELD BY ENGINEER. GENERALLY WILL BE PERPENDICULAR TO STREAM AND OR VALLEY SLOPE AND ALONG CONTOUR TO MIMIC NATURAL FEATURES & TOPOGRAPHY.
 2. DESIGN PORTION OF LOG TO PROVIDE CONTINUOUS CONTACT FROM TRUNK TO LOG TRENCH, AS NEEDED.
 3. PLACE 2-8 LOGS AT EACH DETENTION RIDGE SO THAT MINIMUM TOP WIDTH OF 8' IS ACHIEVED.
 4. FILL DETENTION RIDGE WITH NATIVE MATERIAL THAT WAS EXCAVATED FROM FLOODPLAIN EARTHWORK OR LOG TRENCH.
 5. PLACE SALVAGED SOD MATS ON STREAM BANKS IN NEW FLOODPLAIN, ALL UPSTREAM SIDES OF DETENTION RIDGES AND REMAINING SOD MATS IN CHECKER BOARD EVENLY IN NEW FLOODPLAIN.

Detention Ridge- Morrion-Maierle

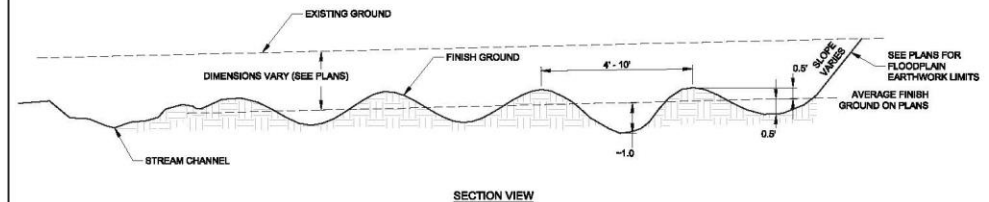
FLOODPLAIN CONTOURING DETAIL
SCALE: NONE
2
C-2

- NOTES:
1. SECTION AND PLAN VIEWS ARE MEANT TO DEPICT GENERAL NATURE AND COMPLEXITY OF FLOODPLAIN ROUGHNESS AND CONTOURING. SEE DESIGN PLANS FOR ACTUAL EARTHWORK CUT AND FILL INFORMATION. FLOODPLAIN FINISHED SURFACE IS MEANT TO PREVENT CONCENTRATED FLOWS AND ENCOURAGE COMPLEX, DISPERSED FLOW AND FLOOD DETENTION.
 2. MICRO TOPOGRAPHY SHALL BE IRREGULAR IN DIRECTION, SPACING AND MAGNITUDE TO PRODUCE NATURAL APPEARING LAND FEATURES AND TOPOGRAPHY. FINISH GROUND SHALL BE DE-COMPRESSED BEFORE SEEDING AND WOODY DEBRIS PLACEMENT.
 3. DEPTH TO MATCH ADJACENT BASE FLOW ELEVATION. COORDINATE WITH ENGINEER PRIOR TO EXCAVATION OF DEPRESSION.

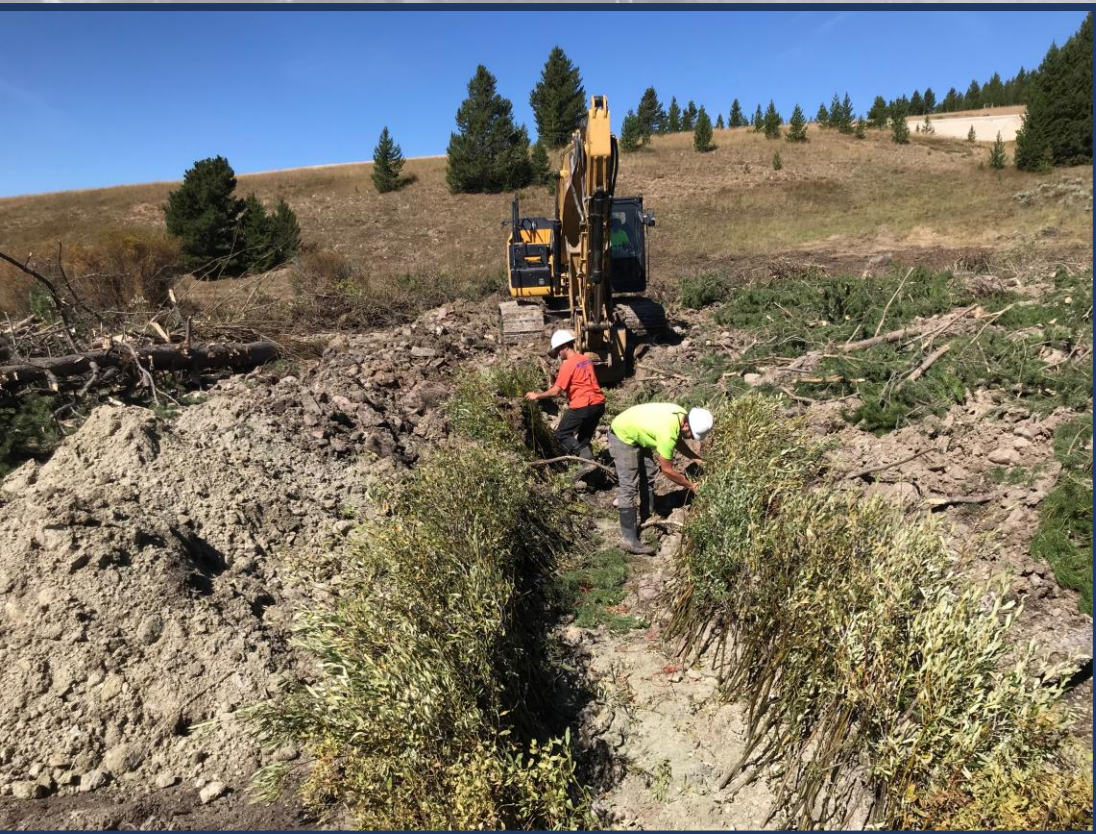
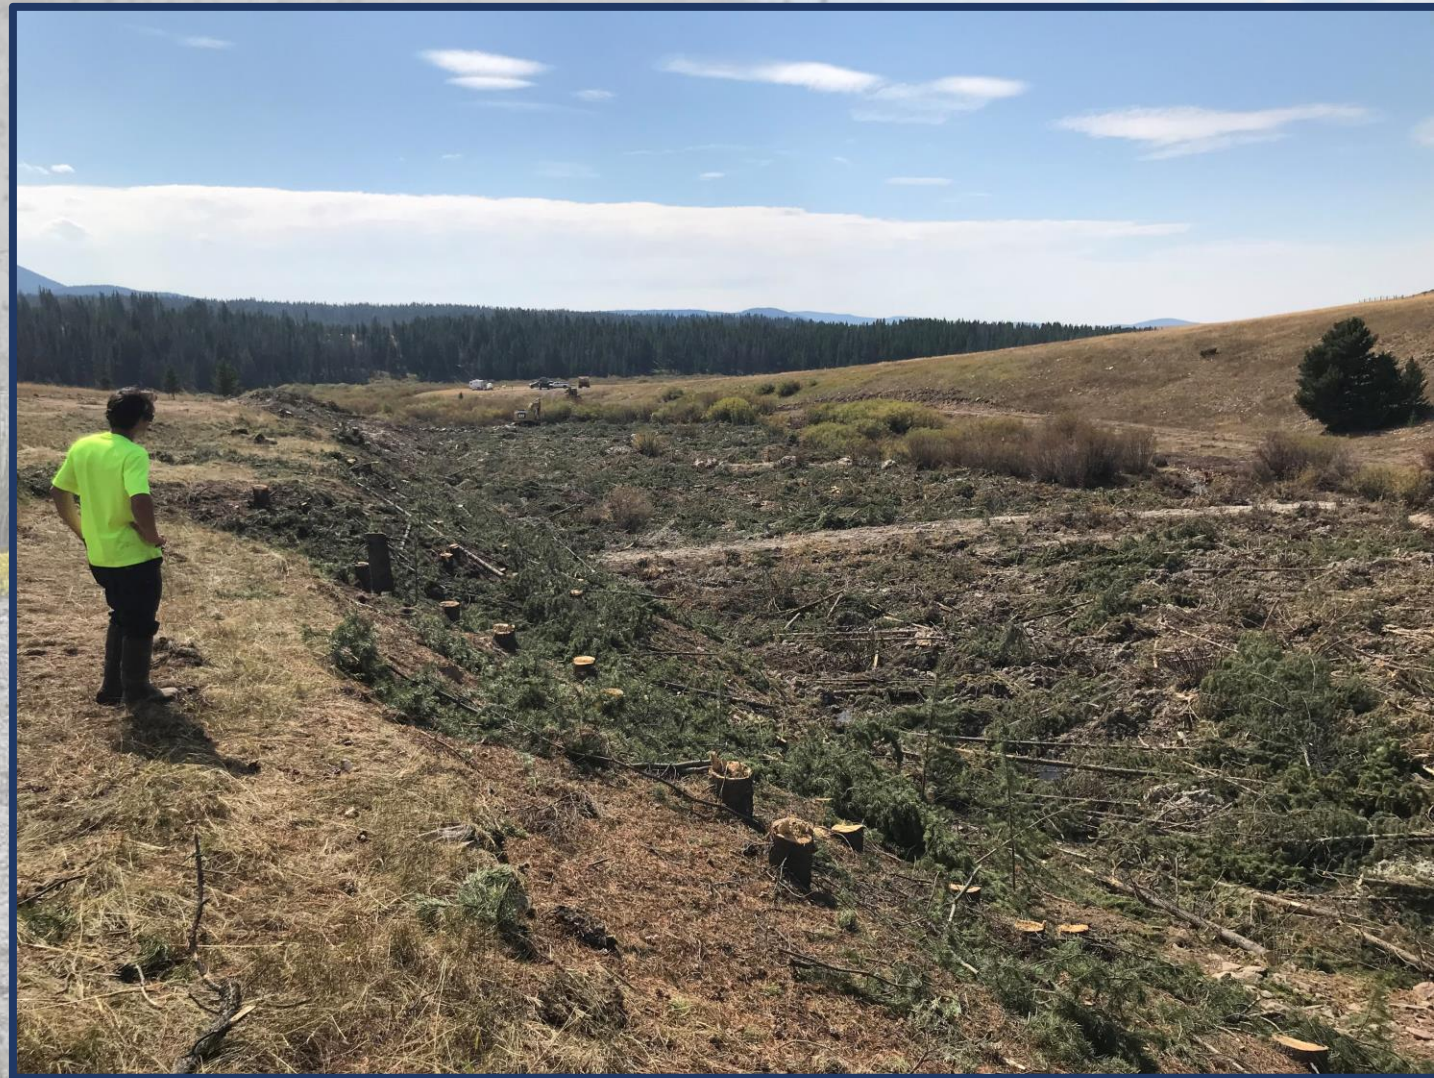
Detention Ridges- Morrison-Maierle

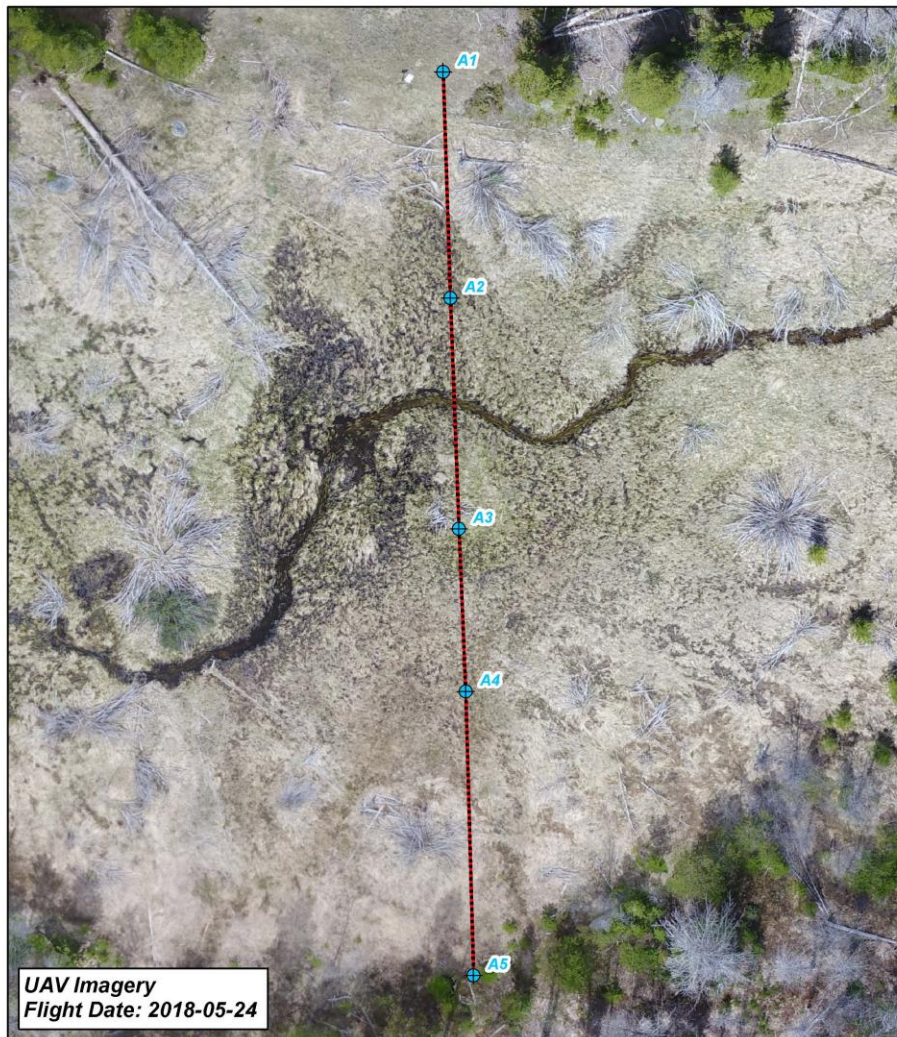
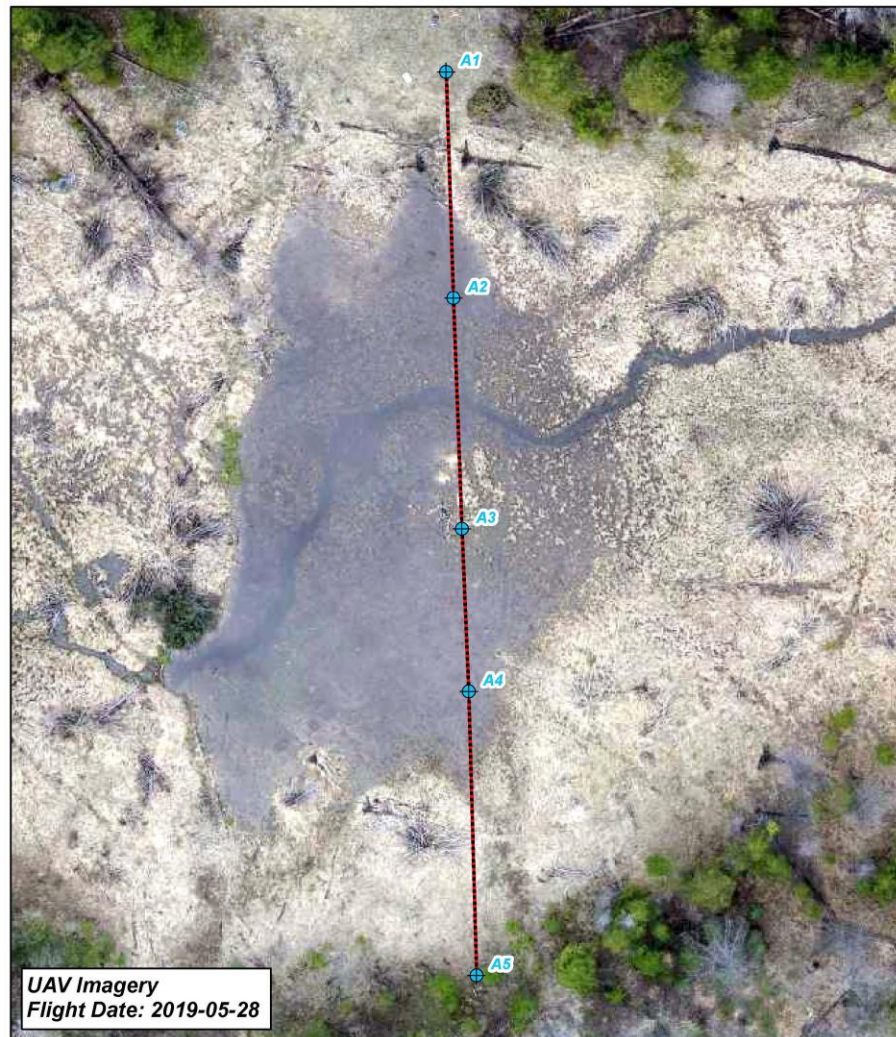
Orthomosaic Comparison	
	JOB#: BHWCM01	SHEET 1
	DATE: 10/16/2019	
	Path: M:\BHWCM01\Gis\GisComp\comp.mxd Author: joshford

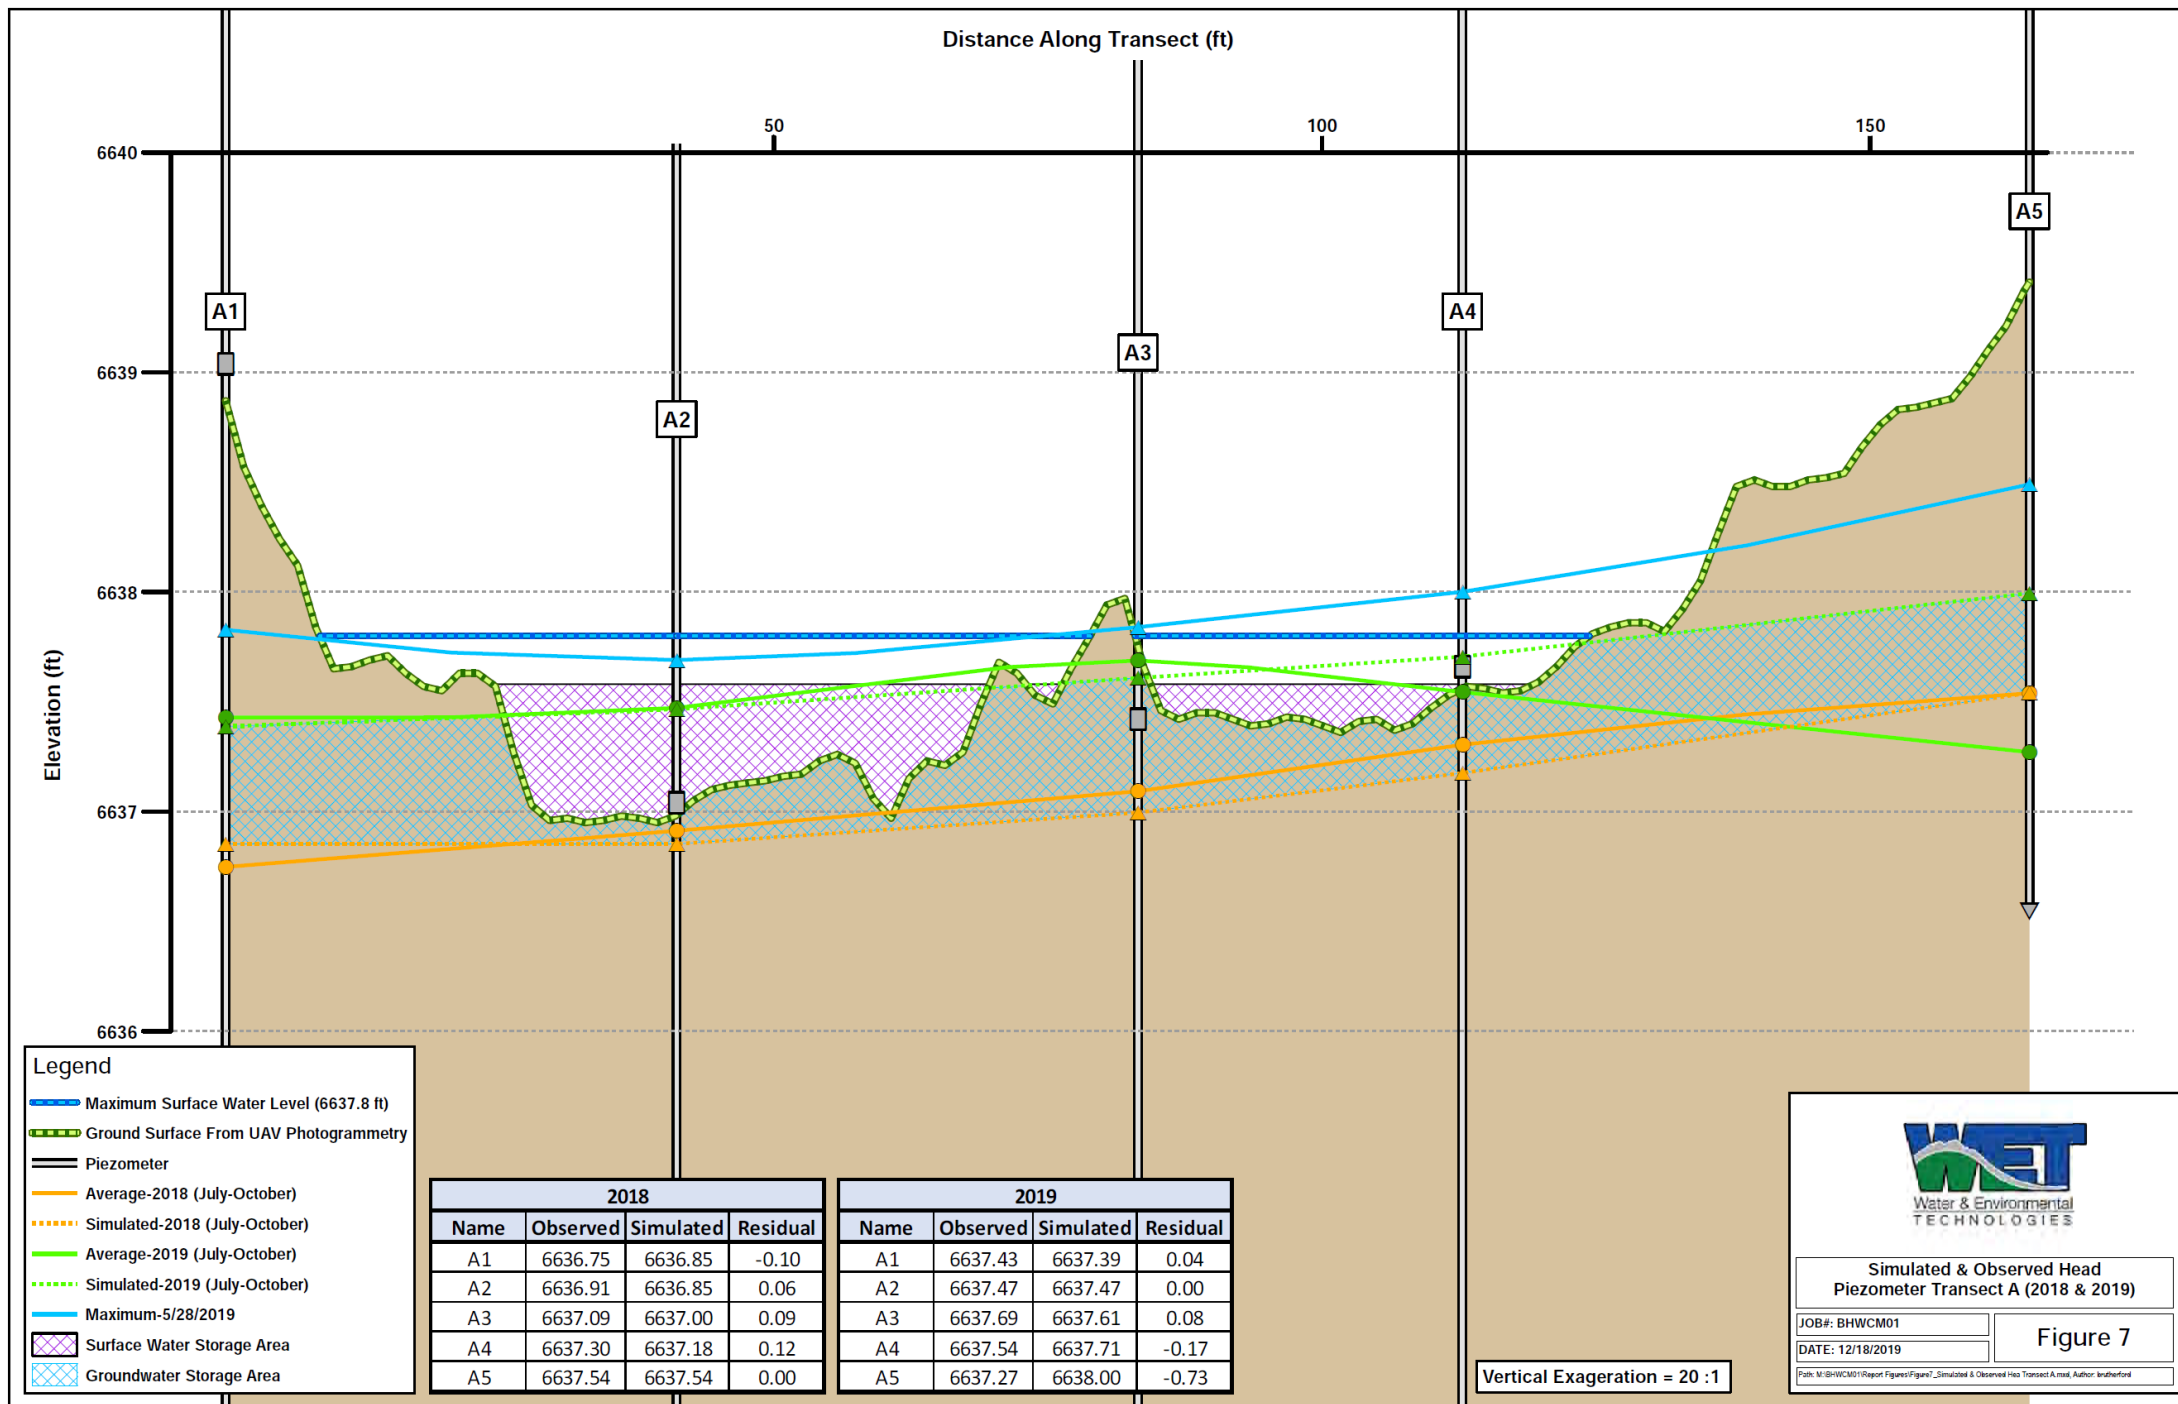
Figure 7

Simulated & Observed Head
Piezometer Transect A (2018 & 2019)

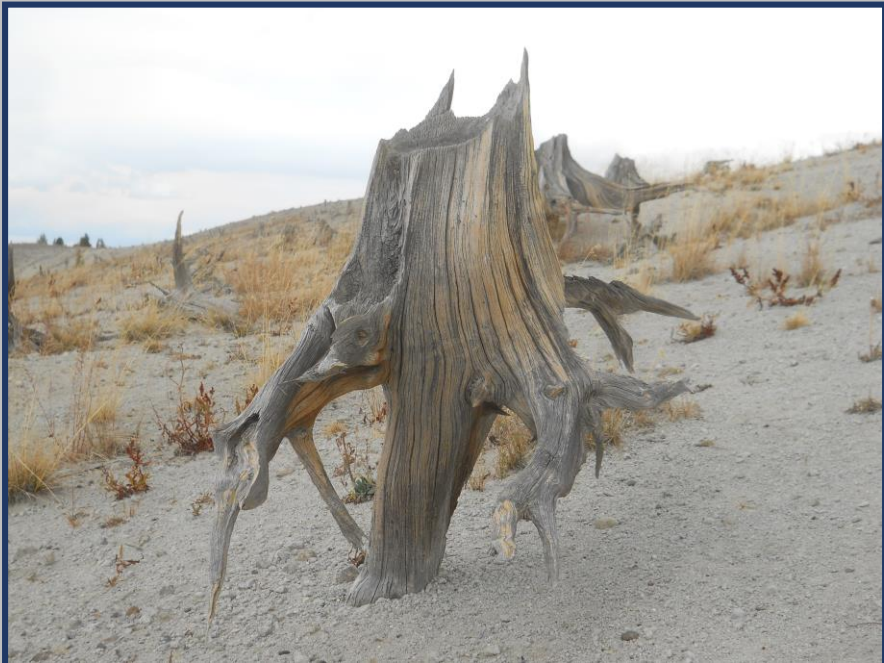
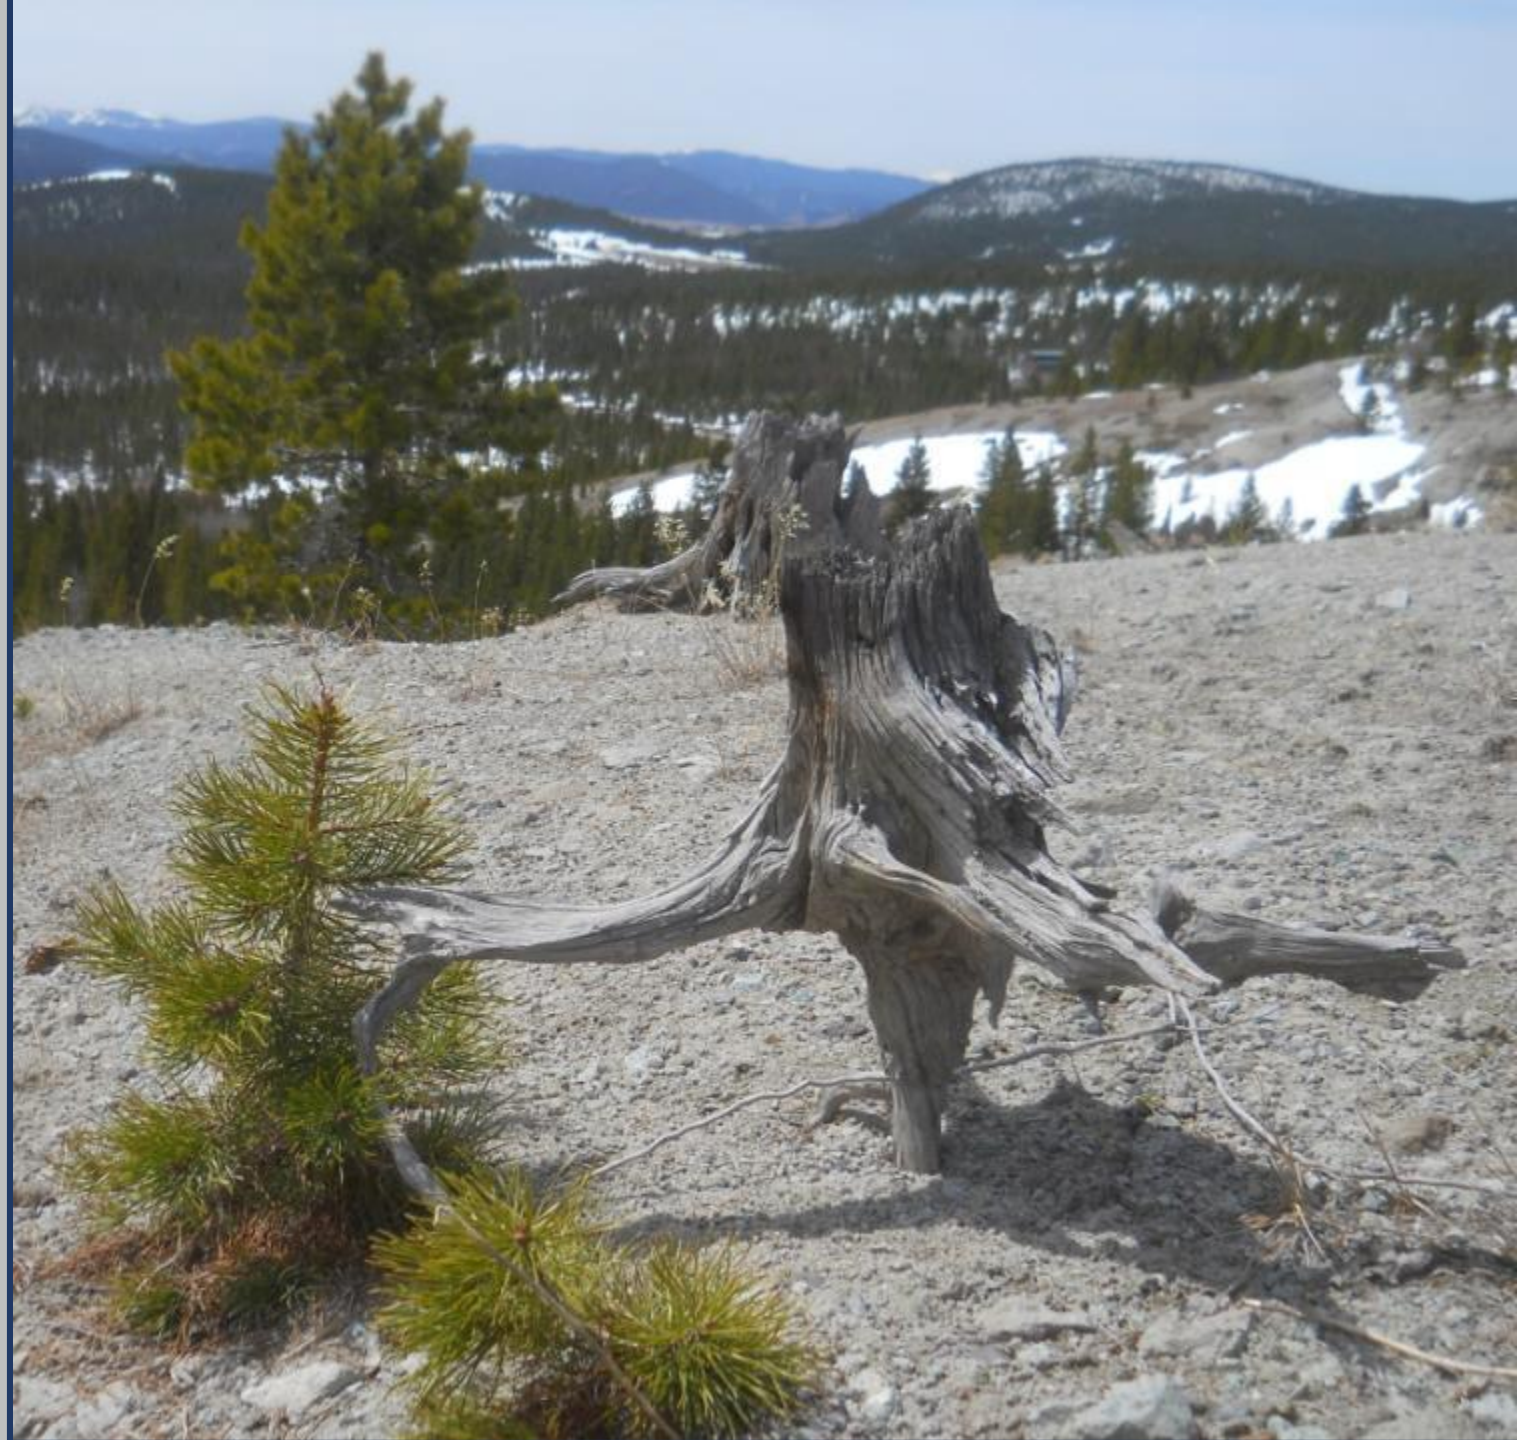
Past the Ecologic Tipping Point

- Loss of 6"-18" of forest soil= most organics and water holding capacity gone
- Friable mineral "soil" of volcanic welded tuff (C-horizon)

- Seed sources few and far between= high predation rates
- Extreme summer, winter climate + wind erosion= low decomposition
- Loss of most natural grade controls and riparian buffer = Sediment Superhighways
- Incised stream channels and aggraded floodplains

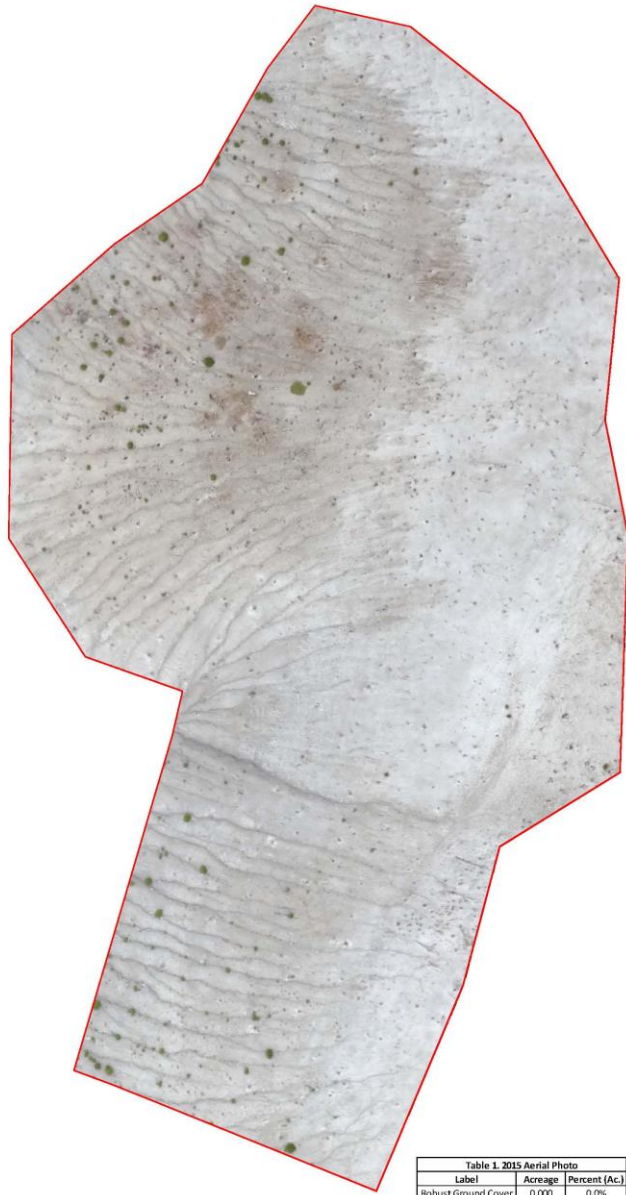
SHEET C9a

Table 1. 2015 Aerial Photo		
Label	Acres	Percent (Ac.)
Robust Ground Cover	0.000	0.0%
Degraded Vegetation	0.292	5.1%
Bare Ground	5.381	94.3%
Coniferous Forest	0.035	0.6%
Total	5.71	100.0%

2015 Aerial Photo - Joyner Gulch

Vegetation Classification - Area 4 Fertilizer Boundary

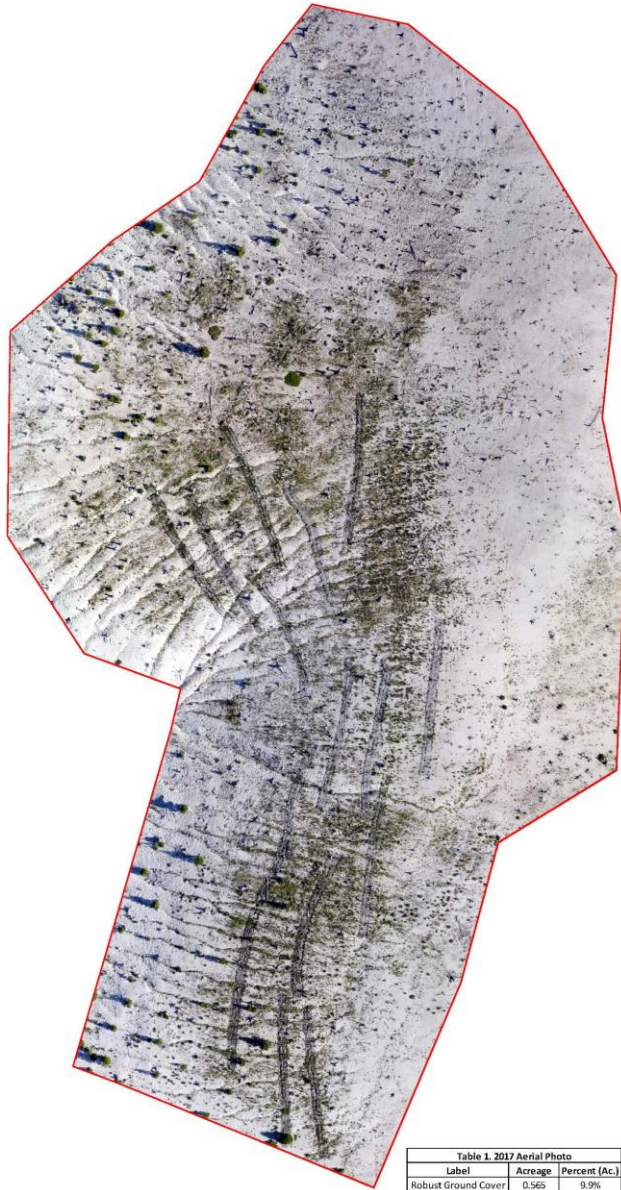
Table 1. 2017 Aerial Photo		
Label	Acres	Percent (Ac.)
Robust Ground Cover	0.565	9.9%
Degraded Vegetation	1.870	32.8%
Bare Ground	3.163	55.5%
Coniferous Forest	0.106	1.9%
Total	5.70	100.0%

Mount Haggin - Aerial
2017 Aerial Photo - Joyner Gulch
Vegetation Classification - Area 4 Fertilizer Boundary
Date: 10/20/2019
SHEET C8a

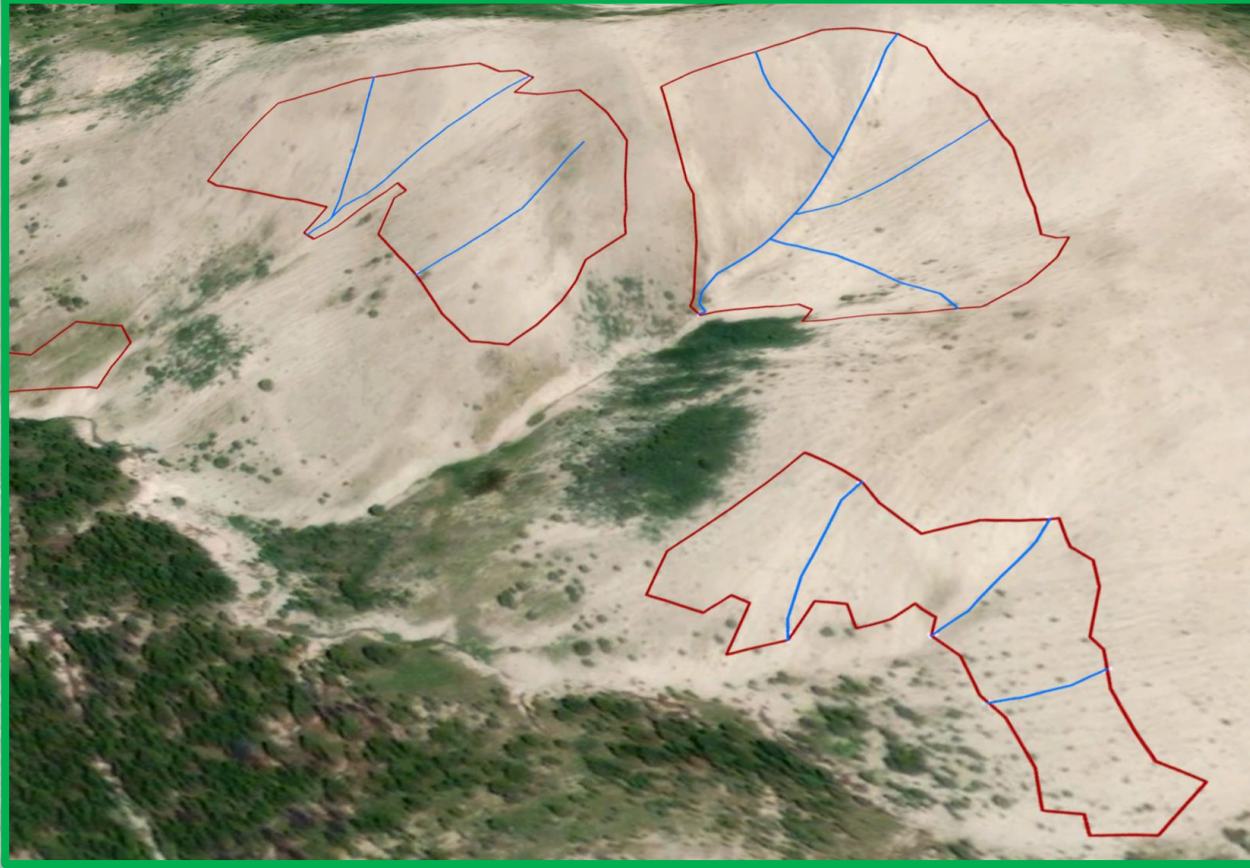
PRE-CONSTRUCTION CONDITIONS

CHANGES TO DRAINAGE BASIN CHARACTERISTICS:

- Increase Flow Length
- Decrease Watershed Slope
- Increase Retention
- Increase Time of Concentration

Dozer Basin Hydraulic Analysis- Pioneer Technical Services

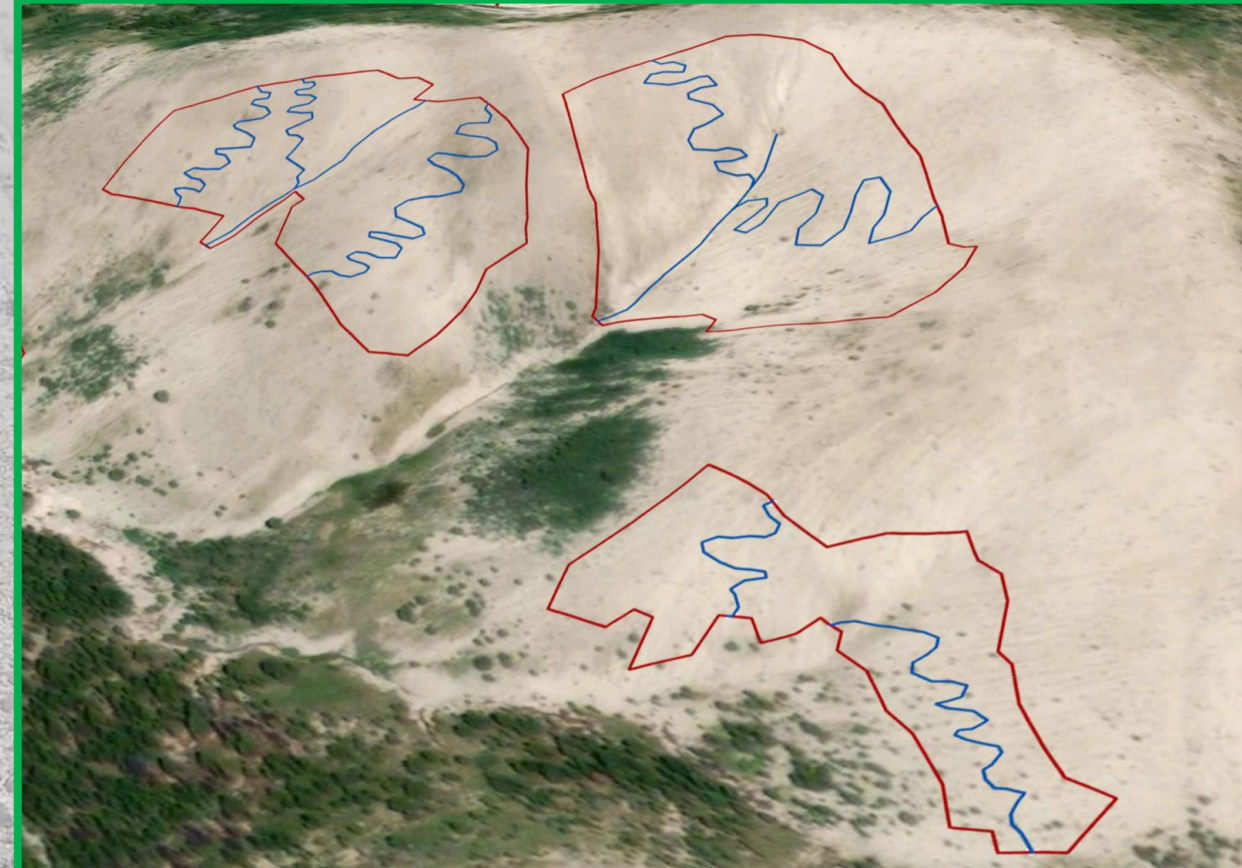
POST-CONSTRUCTION CONDITIONS

RESULTS:

- Reduce Runoff Velocity
- Decrease Peak Runoff Flow Rate
- Decrease Volume of Runoff– 75% at 25-yr event with 70% vegetation cover
