Environmental Site Assessment and Hydrogeologic Impacts to Groundwater at St. Ignatius, Montana and Hanford, Washington

ENVIRONMENTAL SITE ASSESSMENT AND HYDROGEOLOGIC IMPACTS TO GROUNDWATER AT
ST. IGNATIUS, MONTANA AND HANFORD, WASHINGTON

Professional Portfolio

The first chapter, titled "An Environmental Site Assessment, St, Ignatius, Montana", is a Phase I commercial property environmental site assessment (ESA) report, completed on behalf of Pioneer Technical Services, Missoula, Montana (Carter, 2011). The chapter describes the purpose of the environmental assessment, limiting factors, site conditions, and results of visual observations at the site, findings, and conclusions. The entire report is included in this portfolio paper verbatim with minor edits for clarity. Research was focused on whether the property development had affected the local environment. This report touched on many of my academic interests including policy research, property development, and externalities impacting human and environmental health. This report was the first site assessment and characterization I completed since beginning my professional work in the environmental arena.

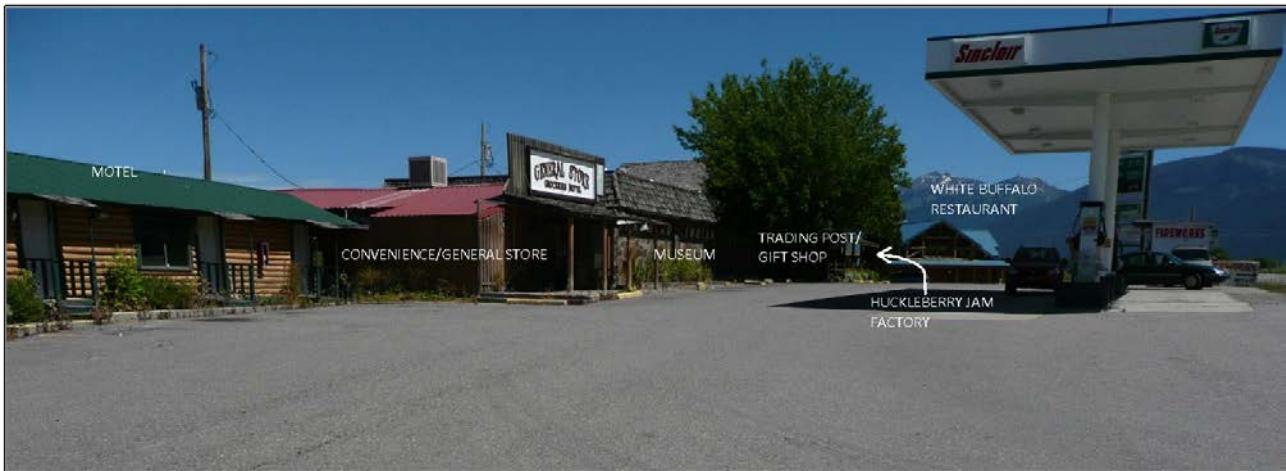
Figure 2. View Looking Northeast to the Main Buildings Fronting Highway 93

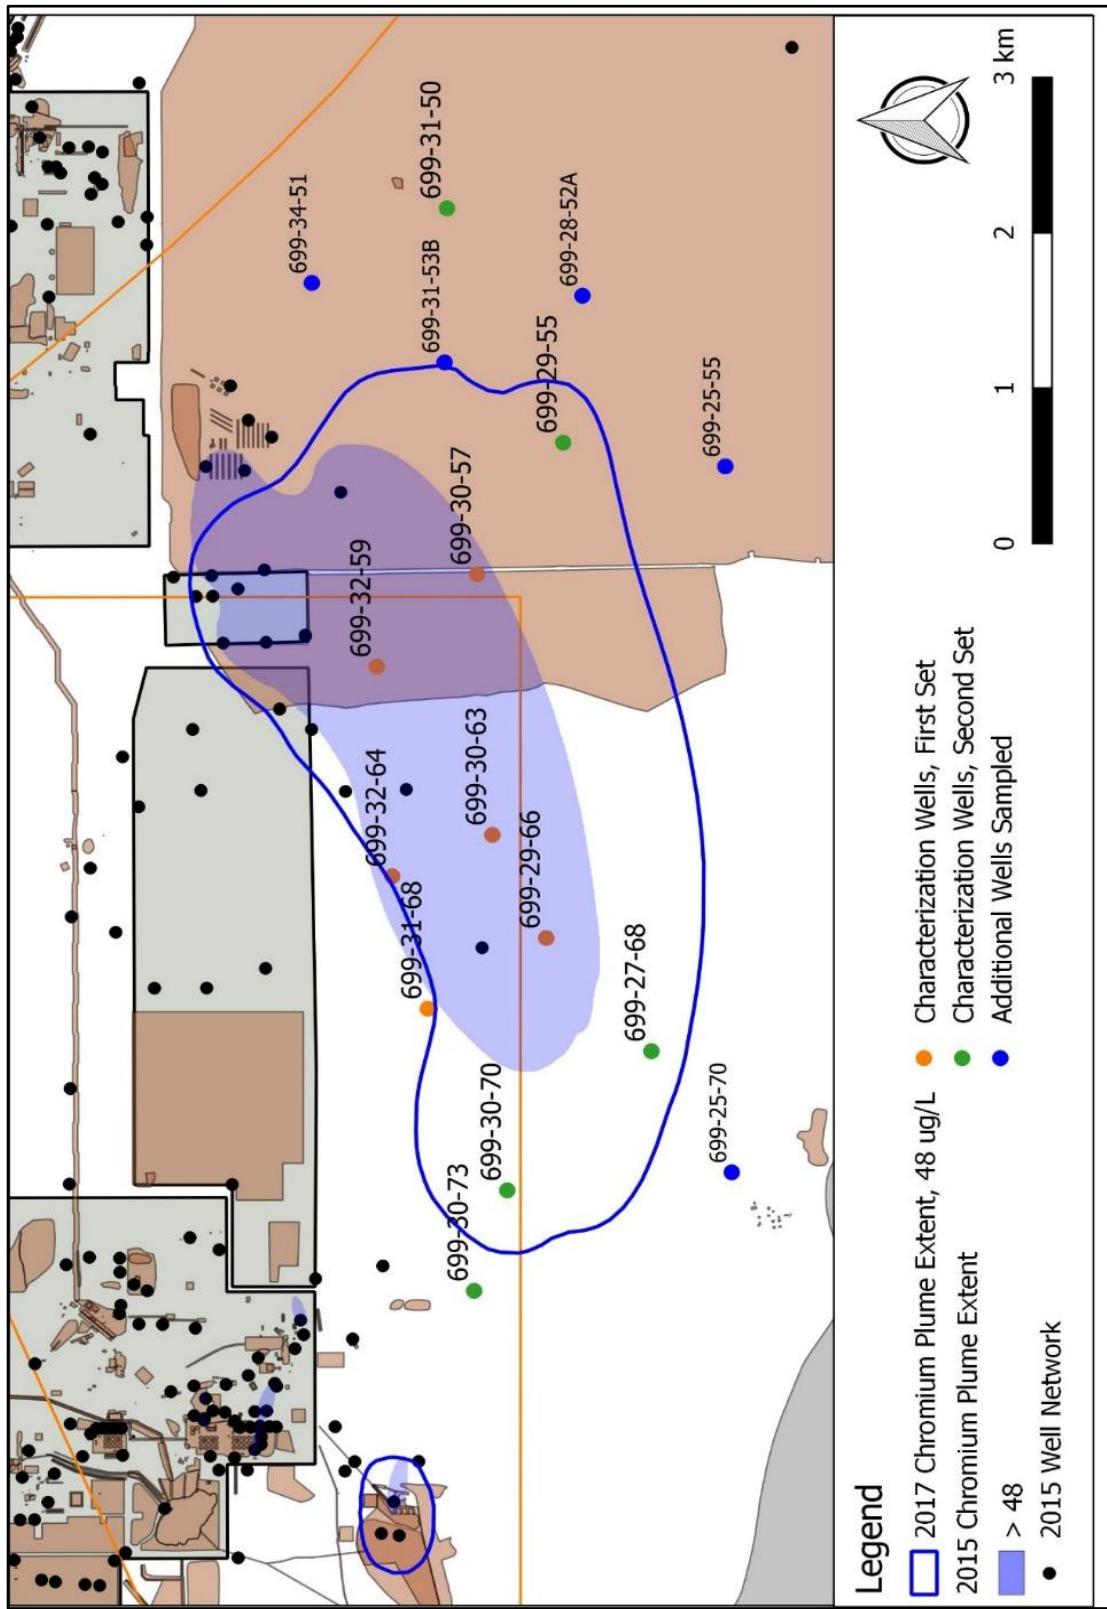
Initially, six characterization wells were planned to further define the nature and extent of the southeast chromium plume to support remedial design. These six wells were located based on the extent of the 2015 plume, shown on Figure 15, which was the latest interpretation at the

start of the drilling program. Chromium concentrations at the two northern wells (699-31-68 and 699-32-64) were consistent with the 2015 plume, but the relatively high concentrations in the three southern wells (699-29-66, 699-30-63, and 699-30-57) indicated that the plume above the 48 µg/L cleanup level extended farther south. The U. S. Department of Energy, Richland, Washington Operations Office (DOE-RL) and the U.S. EPA representatives met on January 19, 2017 to review the findings from the first six wells and agreed to install and sample four additional characterization wells in 2017. These four wells were located to investigate the eastern (699-31-50), southeastern (699-29-55), southwestern (699-27-68) and western (699-30-70) extent of the plume. DOE-RL and EPA also agreed to collect four quarters of groundwater samples from each of the initial six wells to evaluate the groundwater monitoring data for temporary reducing conditions affecting chromium concentrations. Results of the four quarters of monitoring were submitted to DOE-RL in April 2018.

In well 699-30-70, chromium concentrations during drilling were relatively high (average of 91 µg/L), indicating that the plume extended farther to the west. DOE-RL and EPA met on July 20, 2017 and agreed to drill an eleventh well (699-30-73) to define the western extent of the plume closest to the 216-S-10 complex source. Concurrence was reached that 11 wells would be sufficient to define the nature and extent of the southeast chromium plume for remedial implementation, support completion of the Draft A remedial design investigation report, and satisfy the remedial design investigation requirement of Tri-Party Agreement (TPA) milestone M-16-193 for the southeast chromium plume.

Figure 15. Locations of the Eleven Southeast Chromium Plume Remedial Design Investigation Wells
