2002

Bank erosion and metal loading in a contaminated floodplain system upper Clark Fork River Valley Montana

Benjamin John Swanson
The University of Montana

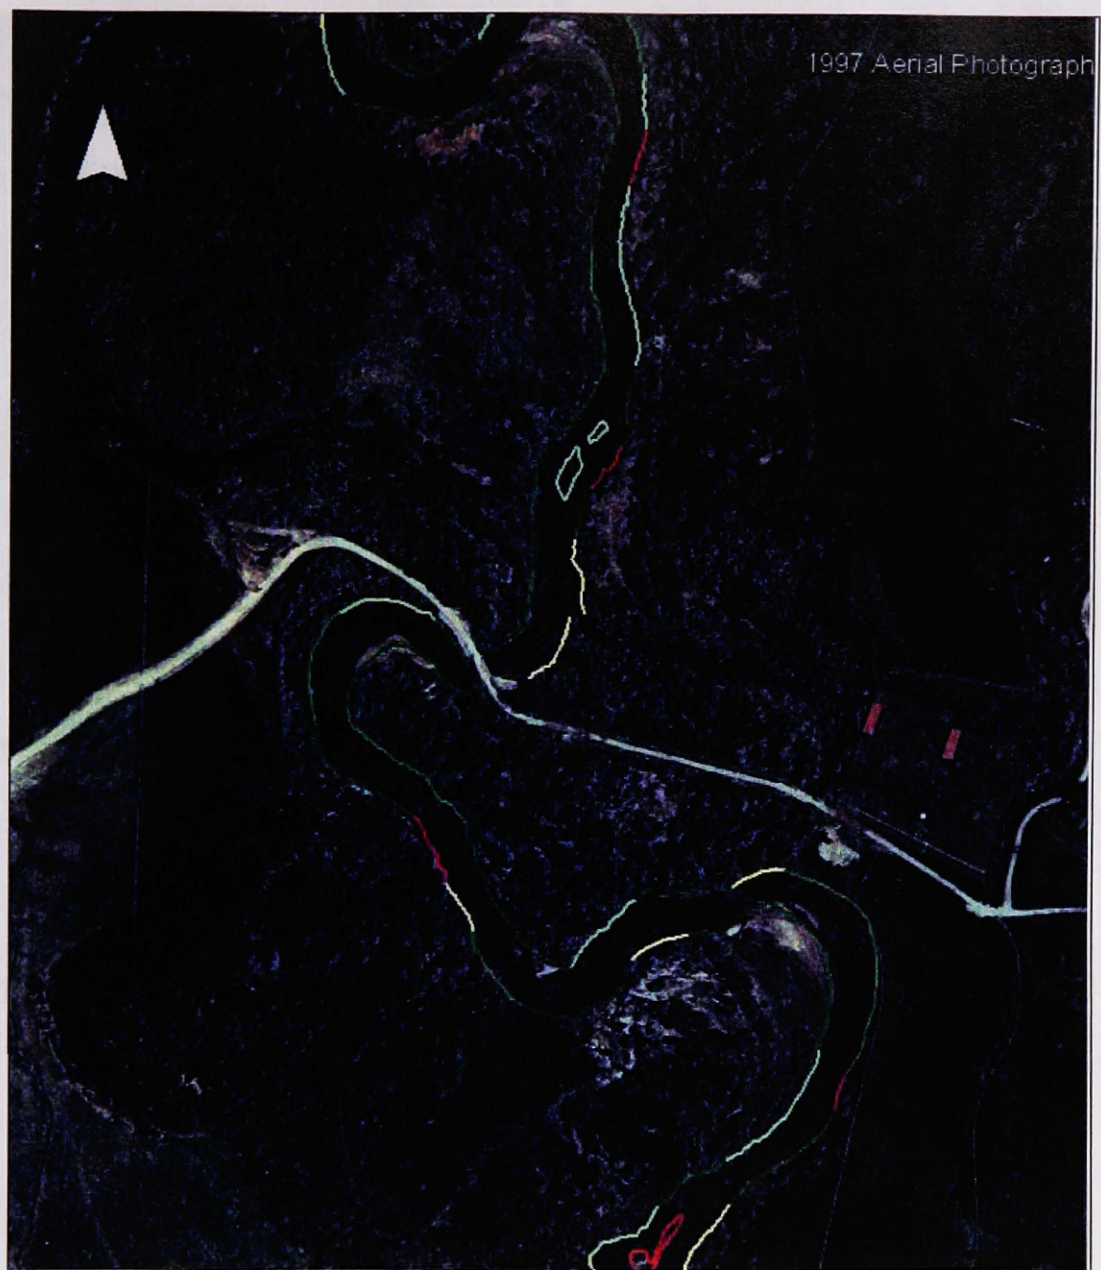
Figure 12d. Average percentage of overhanging (cantilevered) banks within a bank segment.

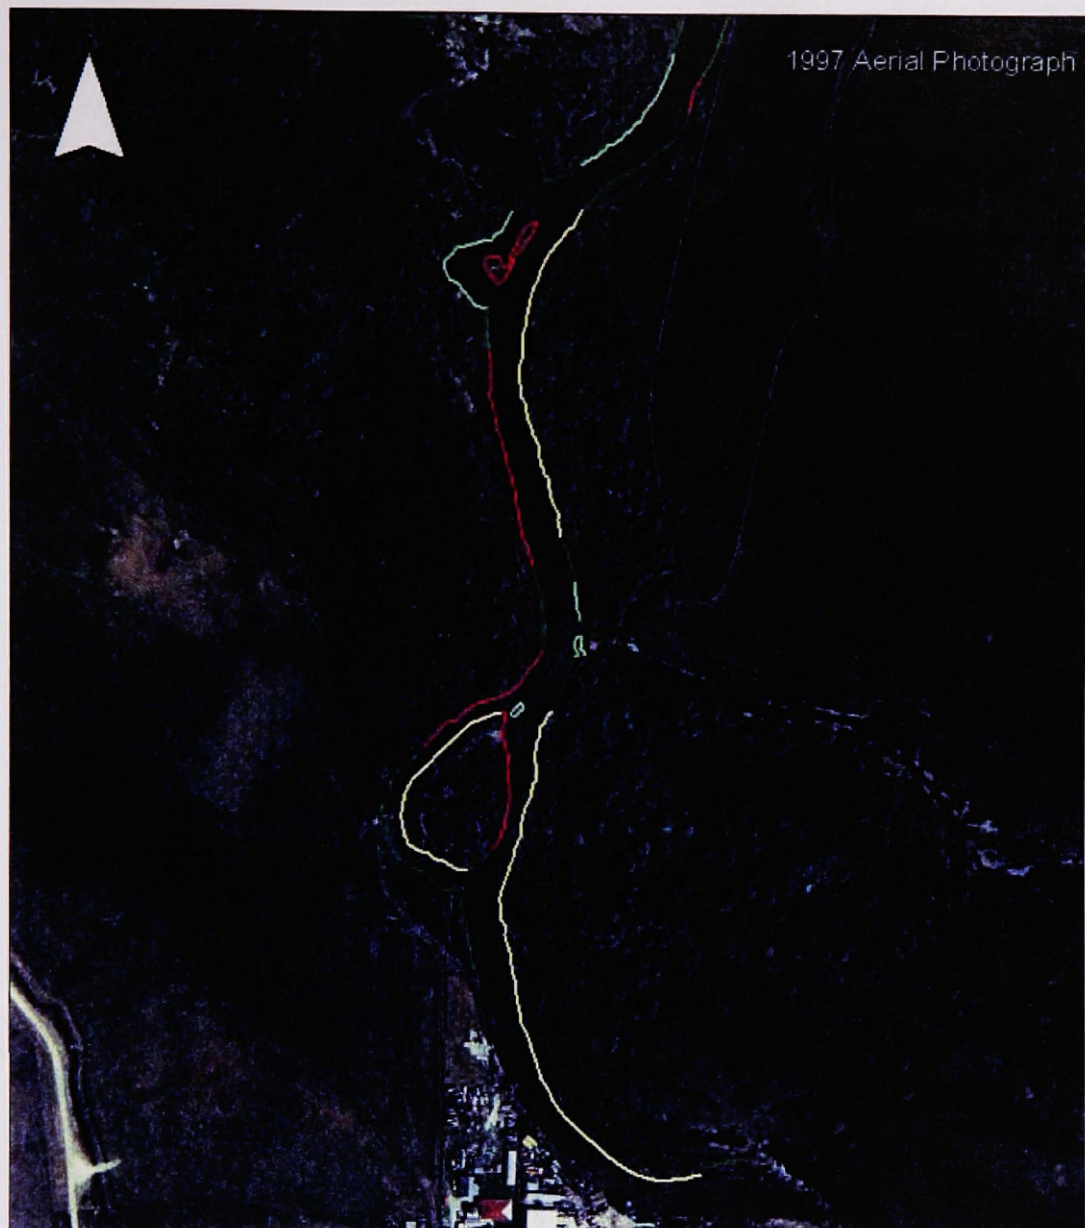
Figure 12e. Average percentage of overhanging (cantilevered) banks within a bank segment.

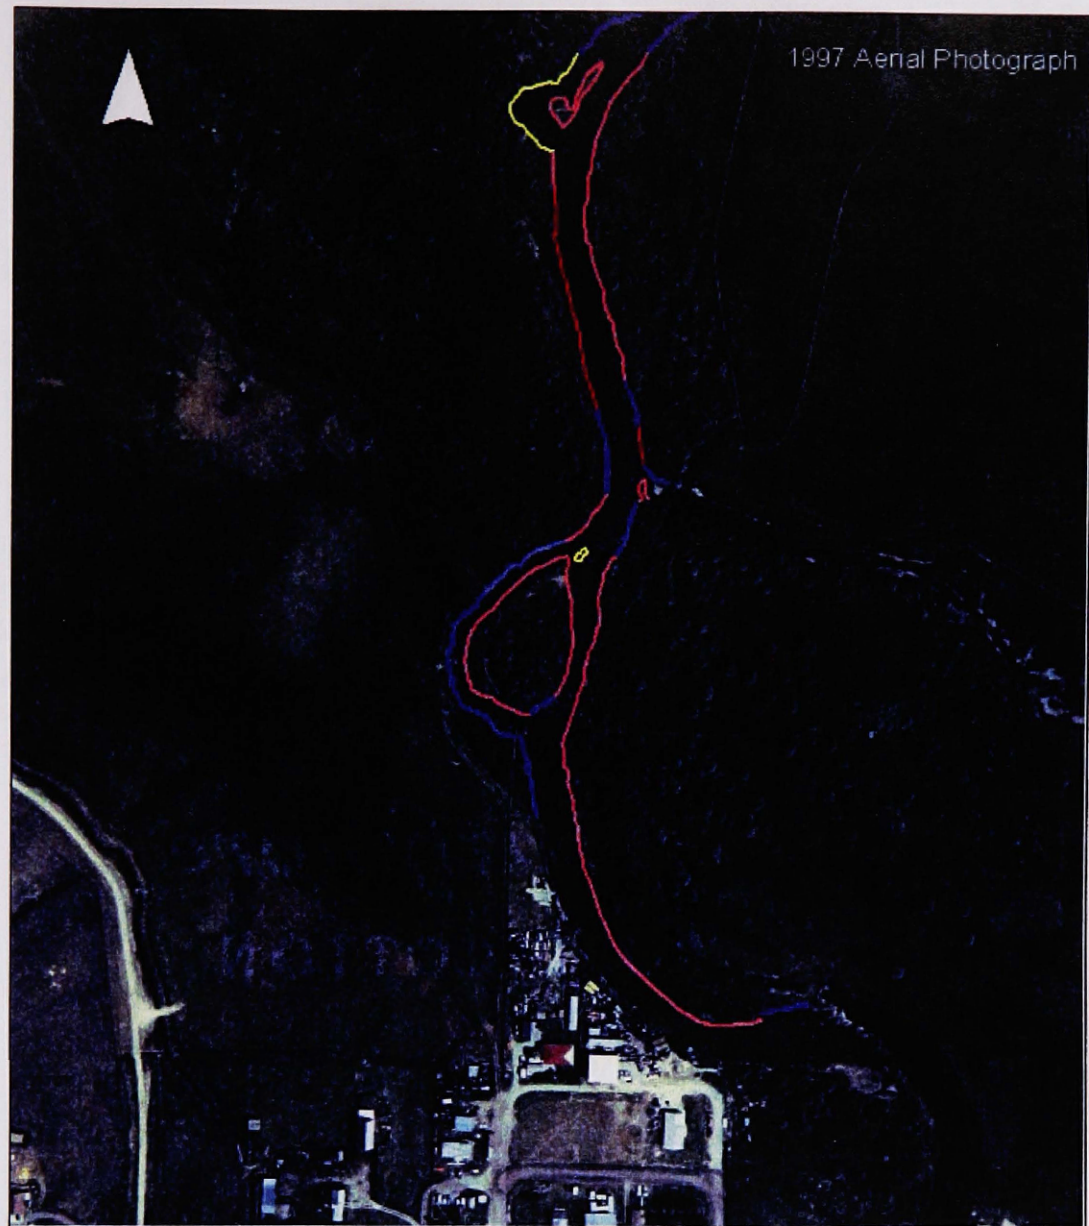
Figure 13e. . Depth of horizontal undercutting beneath overhanging (cantilevered) banks within a bank segment.

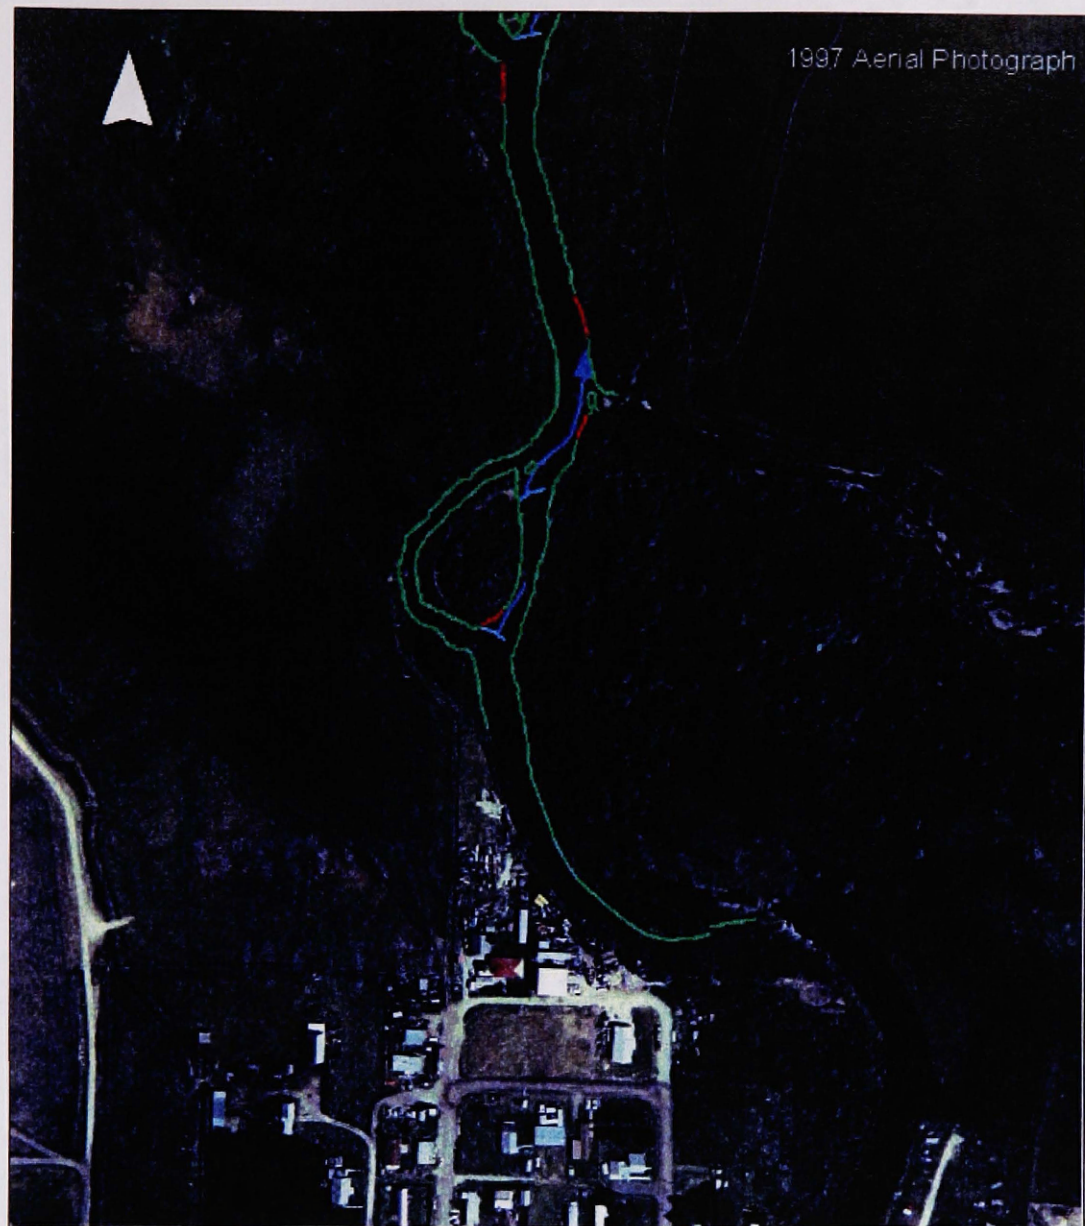
Figure 14e. Percentage of slumping along each bank segment. Riffle location and direction of flow are also depicted.

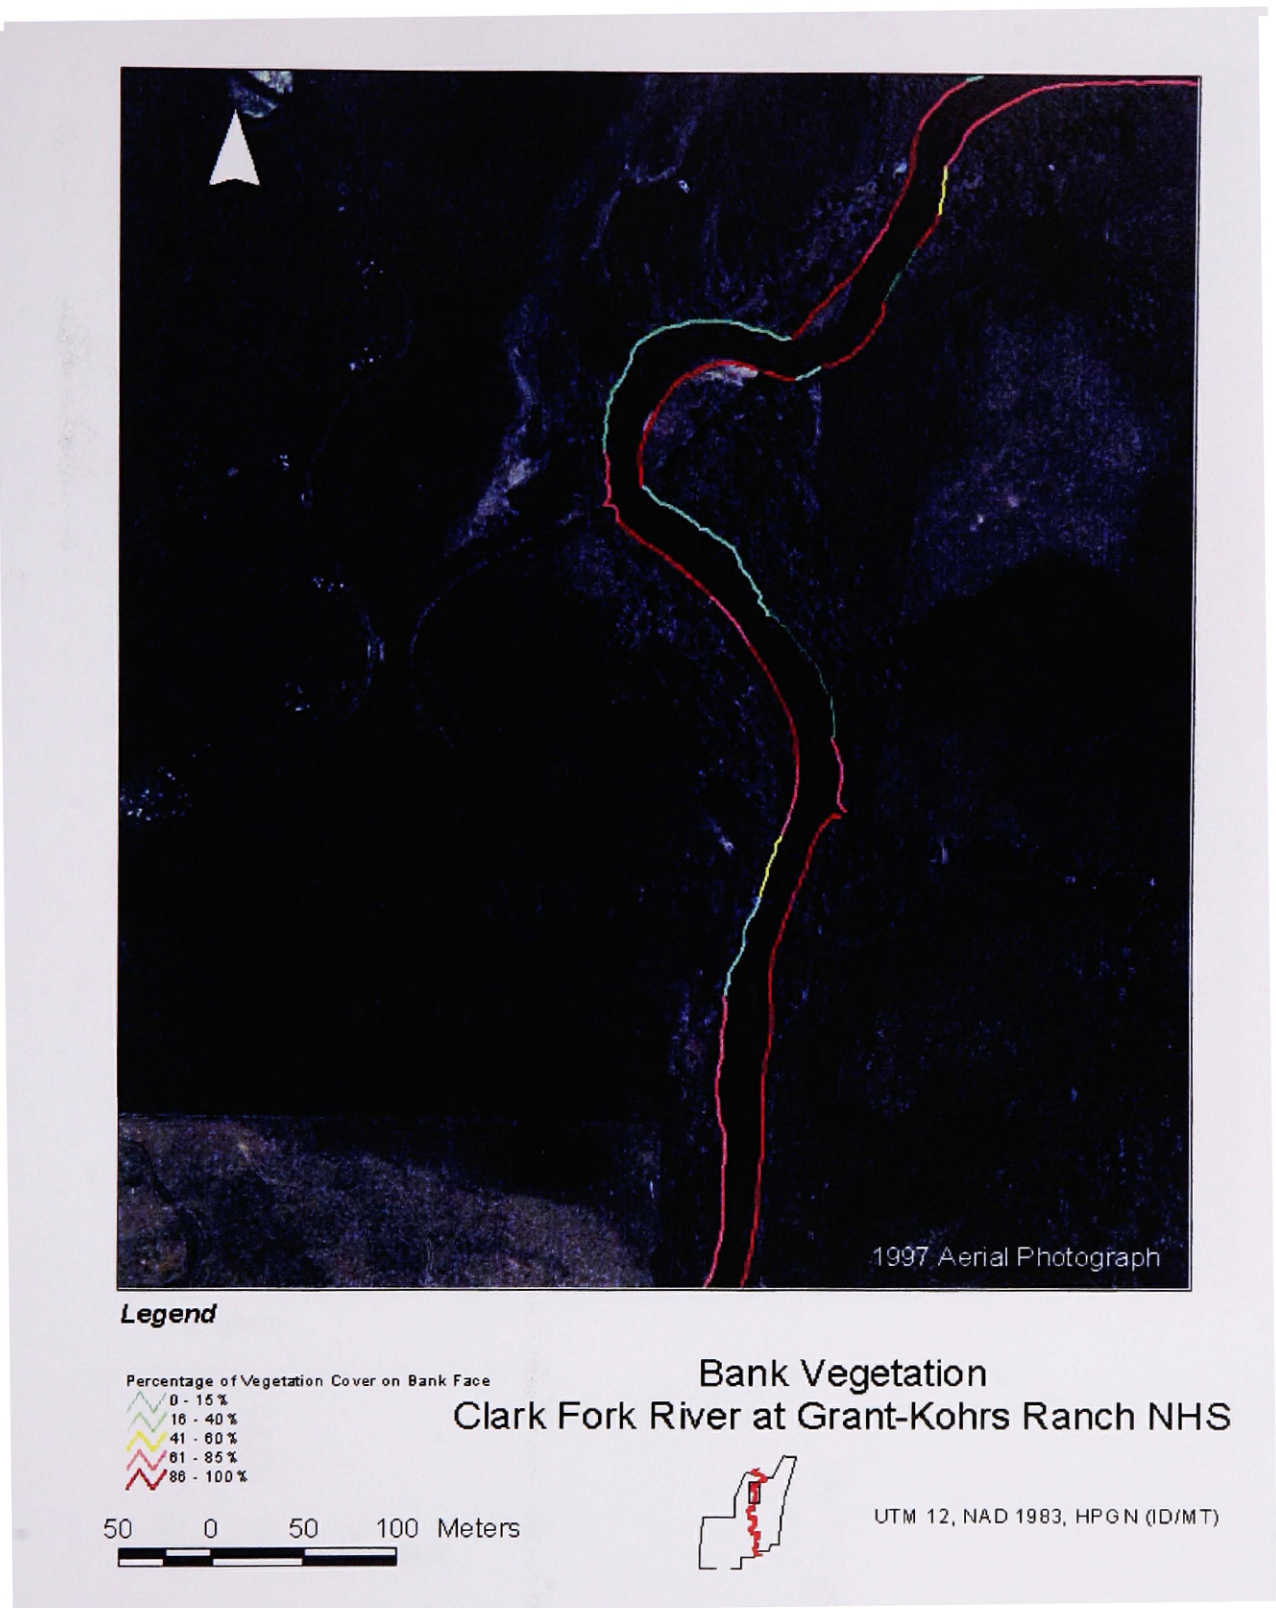
Figure 16a. Percent of bank segments covered in vegetation. Vegetation type was not designated.

(~1 m high) water birch (*Betula occidentata*) and various willows (*Salix* sp.). Various grasses and weeds dominate the rest of the vegetation (Rice and Ray 1985; RWRP 1996). Figures 16 and 17 summarize these data. Convex banks are commonly more vegetated than the concave banks (84% vs. 39%, respectively), and have more woody vegetation within 2 m of the bank (32% vs. 20%, respectively). However, it is not clear whether the banks are more stable due to the vegetation, or if there is more vegetation because the banks are more stable. Other factors, such as watering, grazing practices, thickness of the non-tailings alluvium layer, and fluvial geomorphology can allow for a more stable bank, and therefore allow more vegetation to take hold (RWRP 1996).

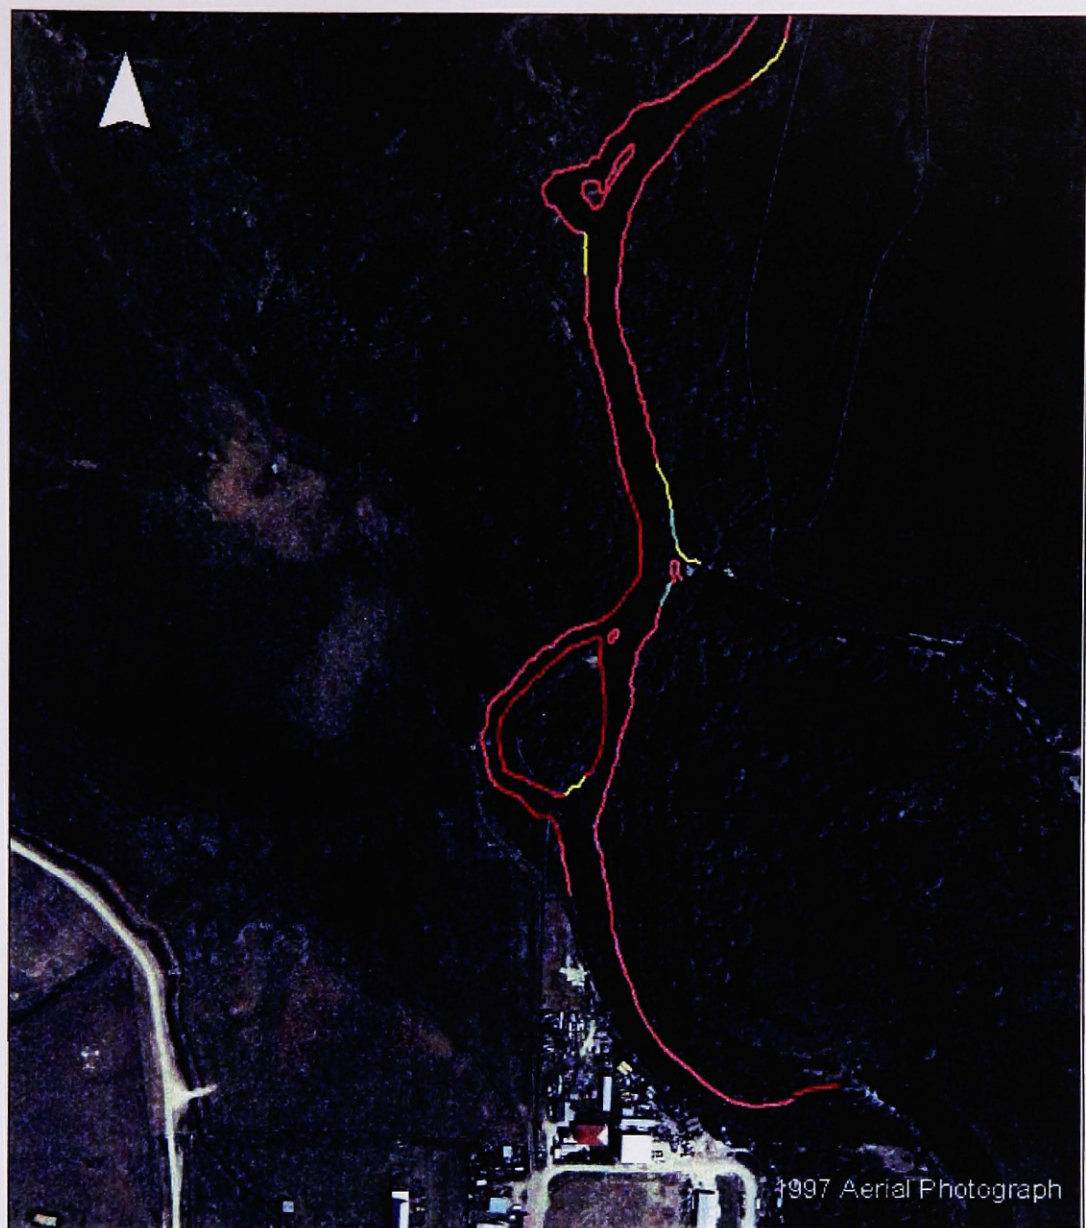
Figure 16d. Percent of bank segments covered in vegetation. Vegetation type was not designated.

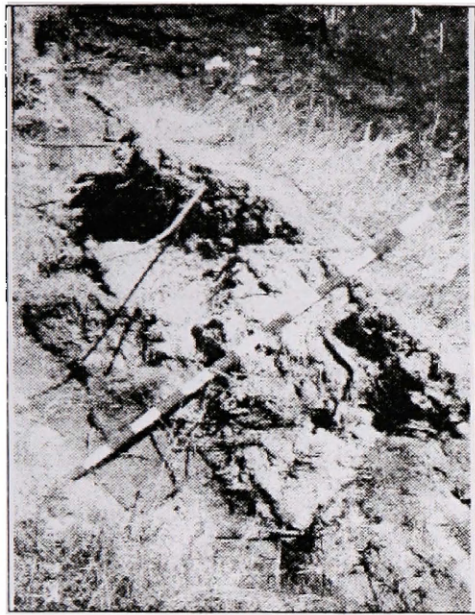
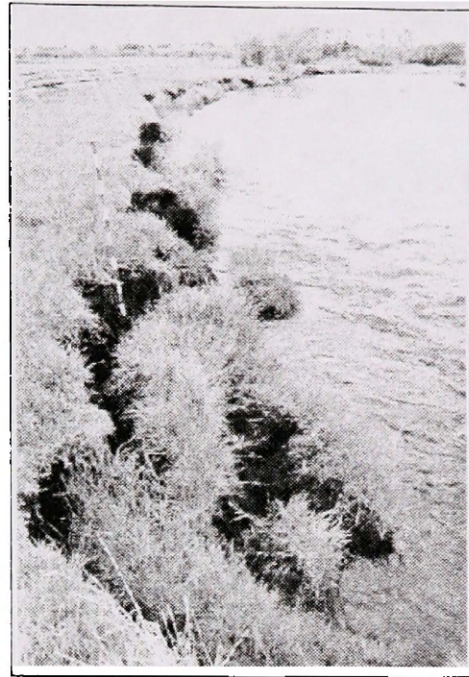
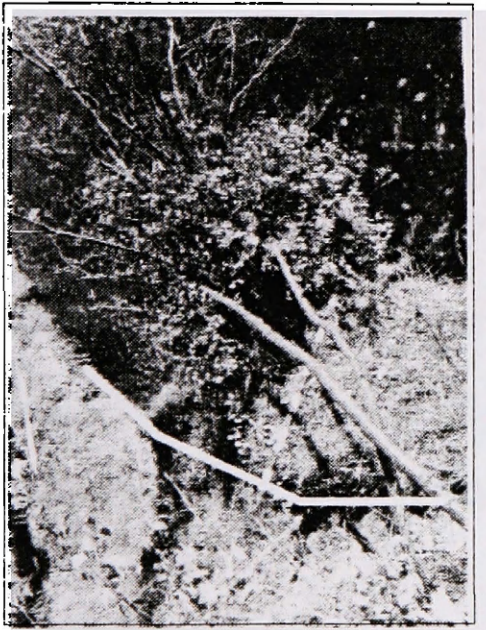
Figure 37. Examples of cantilever failure. The upper photographs exhibit blocks that have detached from the bank (iii and iv, Figure 36) in areas without woody vegetation. The lower photographs show a failed block with a shrub on top. The left photo is an looking almost straight down on the block, and the right is an oblique view. The white lines mark the approximate break from the bank (widening tension crack). Also, notice that the shrub is only about 1 meter high, which is typical in the study reach.

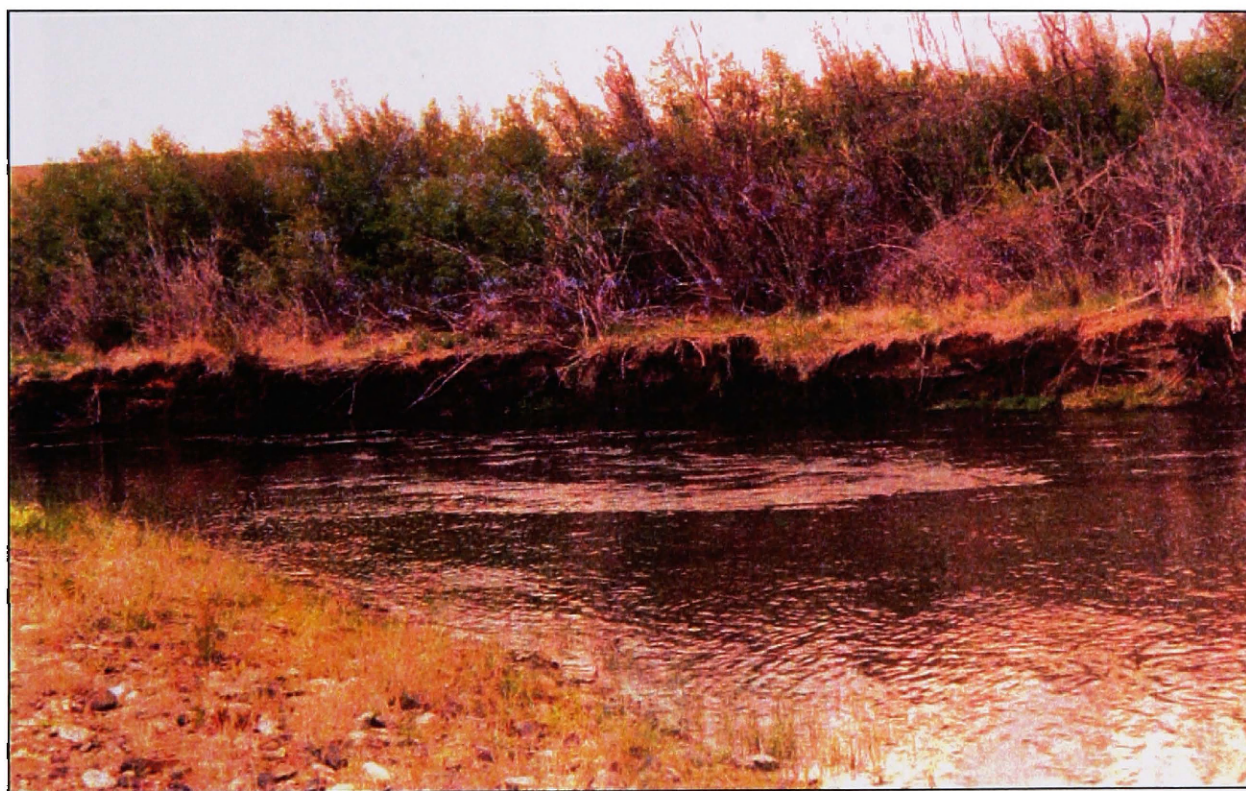
Figure 38. Erosion at vegetated banks (Northbend). Bank is being cut despite the relatively thick woody vegetation. Willows at the bank are dead or dying. Also, few woody roots emerge from the lower bank.

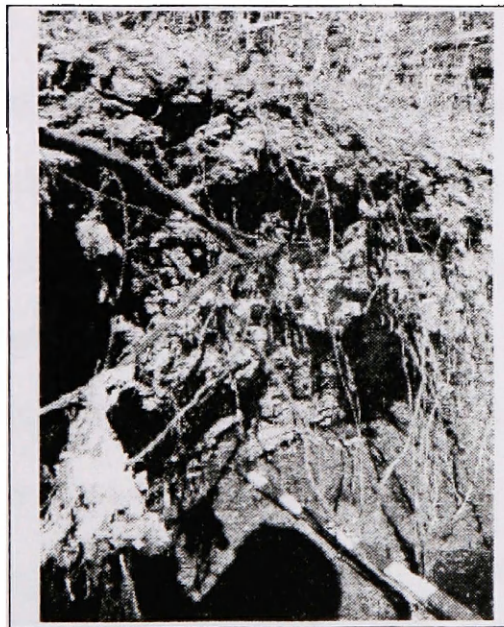
Figure 46. Example of root structure in the bank. Although difficult to see, the hanging roots emerge from the upper third of the bank, and little to no roots can be seen in the lower two-thirds.

Although there is no direct evidence for metal effects on the woody vegetation in the study site, field observations suggest that metals may be affecting the root structures and distributions in many of the same ways mentioned above (Kaputcka 2001). The variability in heights, densities, and distribution of willows within the study site attests to the variability in metals resistance within the *Salix geyeriana* and *Salix elugia* species (Rice and Ray 1985), as well as the spatial variability of metal concentrations (Moore and Woessner 2001). However, some trends are still apparent. The most obvious signs that tailings material limit vegetation growth and productivity are the slickens areas. These areas are characterized by a relatively thick tailings layer lying at the surface, with little or no vegetation cover including grasses and weeds. Where woody vegetation can grow along the banks, it often consists of short willows and water birches, usually not more than a meter high. Directly along the banks, where roots are exposed and dessicated and metals can accumulate due to the wicking process described in Brooks and Moore (1989), the vegetation is often completely dead. Even in areas with relatively tall or dense vegetation, the tailings and lower bank layers are devoid of living roots which otherwise might hold the sediments in place. In many places along the banks the roots seem to be avoiding the tailings layers altogether by growing horizontally instead of vertically (Figure 39, 46, and 48).

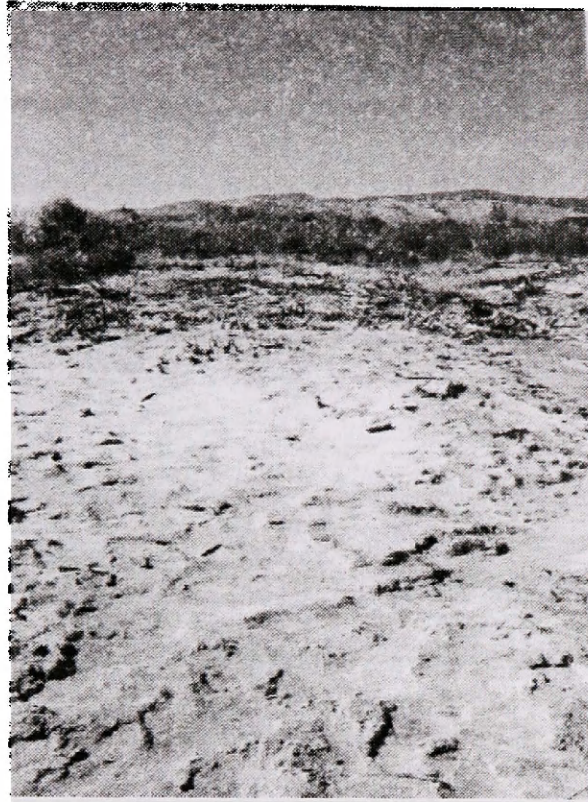
Figure 49. Example of a slicken. Lighter colored areas at the center of the photograph are salts that form on the surface. Short spikes above the salts are the remnants of willows.

Besides being indicators of the phytotoxicity of the tailings' metals, slickens are also important to erosion and metals loading to the river. Salts composed of the metals can form on slicken surfaces, where they can subsequently dissolve in runoff during floods or large precipitation events and flow into the channel (Figure 49). This process makes slickens a direct contributor to metal loading to the river and the floodplain. However, they also have the potential to be indirect contributors through surface erosion. If water in the river exceeds flood stage, then the excess water will flow across the floodplain. Vegetation and other obstructions will slow down and direct the flow to areas with less resistance, which should include the barren slickens. If there is enough water and velocity gradients are high, the concentrated flow will erode through the unprotected slickens, which in turn creates a small channel which "attracts" more water, causing more incision. If this process continues, the new channel will be deep enough to undercut the floodplain vegetation, widen, and move even more contaminated material to the channel and other areas of the floodplain. Finally, because the eroded material is derived from the surface sediments, it will be comprised mostly of tailings material instead of the combination of tailings and pre-tailings material that erodes from the banks.
